Soil liquefaction and subsidence disaster in İskenderun related to the 6 February 2023 Pazarcık (Mw: 7.7) and 20 February Defne (Mw: 6.4) earthquakes, Türkiye

Hüseyin ÖZTÜRK^{1*}, Craig A. DAVIS², İbrahim KUŞKU¹, Süleyman DALĞIÇ¹, Cem KASAPÇI¹,
Muharrem Alper ŞENGÜL³

Abstract: The Mw 7.7 Pazarcık earthquake on February 06, 2023, struck southern Türkiye, causing typical liquefaction along the shores of İskenderun Bay. This liquefaction was characterized by lateral spreading, subsidence, and flooding. Subsidence-triggered sand ejection, water flows, and opening cracks were identified in areas spanning approximately 2 km in length and 300 m in width.

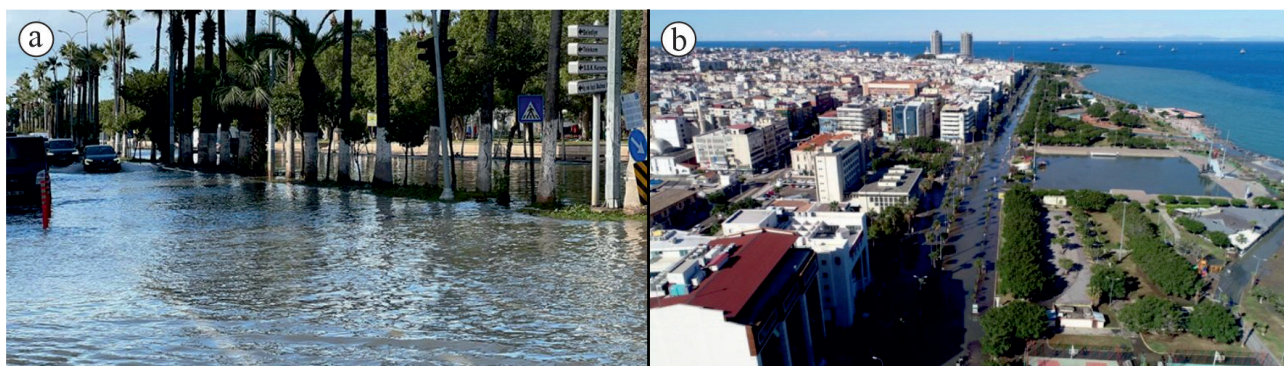
Figure 4. Water inundating the streets along the İskenderun coast following the February 6, 2023, Pazarçık earthquake. Figure 4a is an aerial photo taken facing southeast from the position marked in Figure 3. Figure 4b is an aerial photo taken facing northwest from the location indicated in Figure 3¹.

To investigate the media report suggesting that the flooding shown in Figure 4 was from the sea, no sand or living remains related to the sea were found on and between the rock blocks laid on the coastal belt. This clearly shows that no water came to the roads from the sea. There was also no evidence of an influx of seawater anywhere along the grassy areas located along the shoreline. Figures 7 and 8 provide visual evidence of this observation. Figures 9a–9d plot lateral spreading cracks and sand cones associated with the main earthquake. Figure 9 plots are using Google Earth views. It is noteworthy that taller buildings settled much more than shorter ones. For instance, some small buildings remained at a relatively higher position.

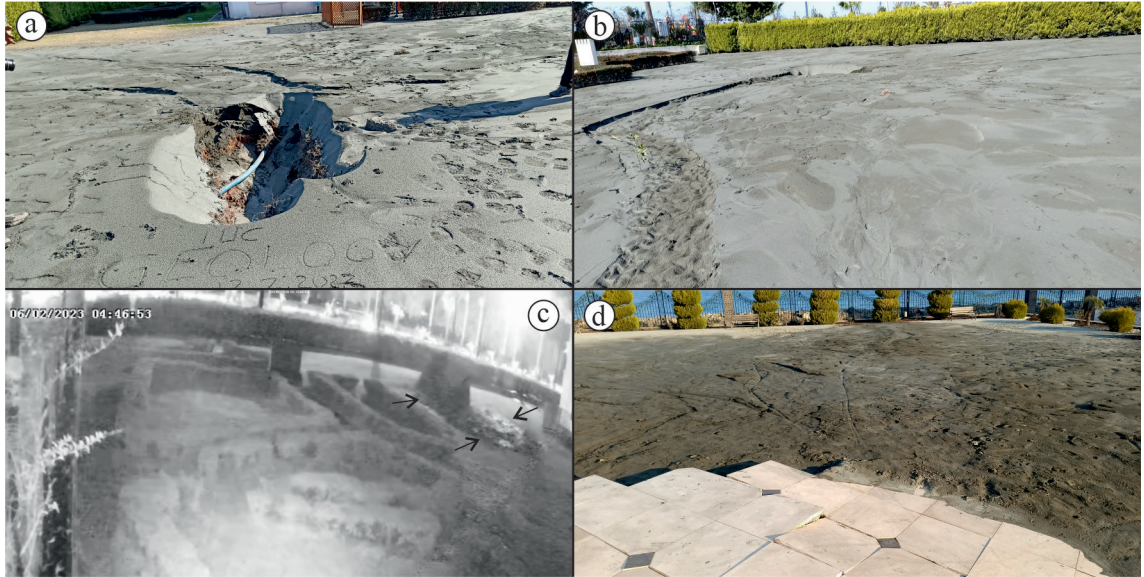
liquefaction process and left behind from the waters gushing from cracks in the fill and alluvium. Figure 5 displays photographs and a still shot image taken from a recorded video from a security camera at a military building. The location of these images can be found with the identification numbers 5a to 5d in Figure 3. Upon examination of the video record obtained from the military building, water and soil are observed gushing out of the ground at a height of about 2 m at 29 min after the earthquake². The field investigation identified this as emerging through an elliptical slit formed naturally in the ground, with a length of 2 m and a width of 1 m. At least 80 m³ of silty sand material from the natural ground is estimated to have been ejected, based on a measured 20 m × 20 m × 0.2 m volume of soil remaining behind this liquefaction water outlet. Figure 5d is taken at the Nihal Atakaş Mosque and corresponds to the same number in Figure 3. This location also experienced liquefaction and silty water outflow in the courtyard of the Nihal Atakaş Mosque located on the coastline; here, about 45 m³ of sand remained on the ground surface, with dimensions of 15 m × 20 m × 0.15 m.

Figure 5. a) Field photograph of the spray point. b) Field photograph of the accumulation area of water and sand spray in the garden of the military building on the coast of İskenderun. c) Still image from the video recording capturing the water tap incident that took place 29 min after the earthquake. d) Sand residue observed in the garden of Nihal Atakaş Mosque.

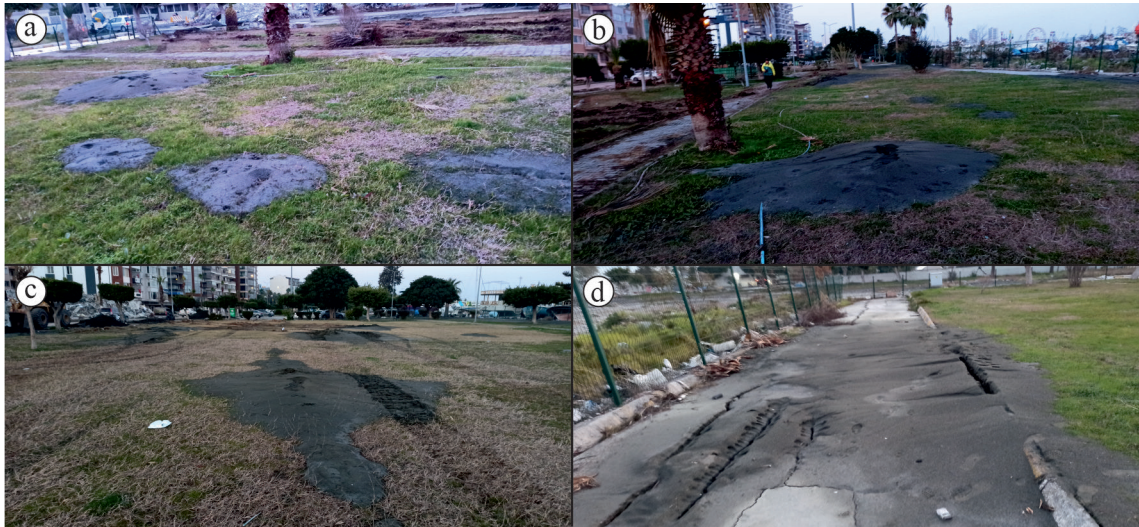
Silty water emerges from cracks along the entire filled area along the coastline, with sandy silt accumulating in the form of volcanic cones at the edges of these cracks. Liquefied sandy silt was sampled from these two points. The nature of the particle size fractions of the samples is provided under the liquefaction heading. Figures 6a–6d show sand boils from liquefaction that developed within the artificial fill placed along the coastal zone in grassy areas along the beach. Ejecta was also observed at the base of the electricity poles and along the outer edges of the subsided buildings. Figure 7 demonstrates how fine-grained greenish-black silty sand was discharged onto the ground surface, not only from the cracks in the fill (Figure 7a) but

Figure 6. Silty sand cones formed in parks, at the base of poles, and around foundations along the shoreline. These resulted from water-soil slurry ejected from the ground due to liquefaction. Image locations are indicated in Figure 3.

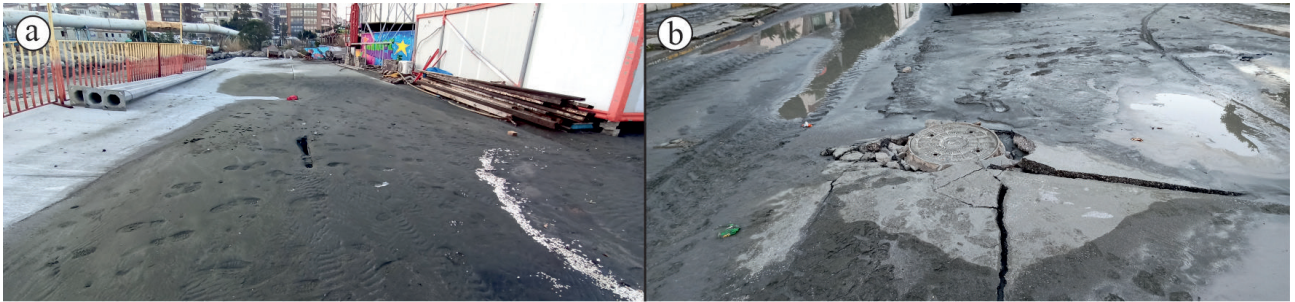
also from around the sewer manholes (Figure 7b). Field observations indicate that a significant amount of water flowed to the surface from around the manholes. The relative movement between the manhole and the paved street resulted in the breaking of the pavement. This could have occurred from uplift of the sewer from pressure coming from the bottom of the sewer manholes and/or settlement of the ground around the manhole.

Figure 7. a) Sand emerging from the crack in the amusement park area. b) Sewage water collection structures have risen on the main street due to subsidence of soft sediments. Image locations are indicated in Figure 3.

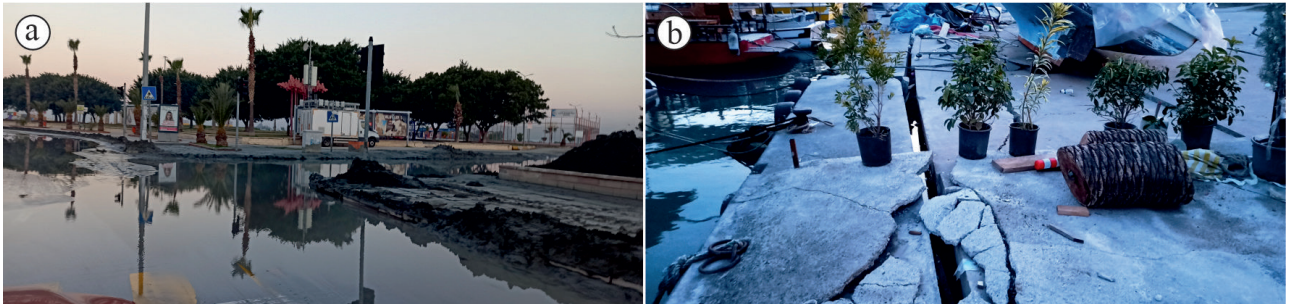
Figure 8. a) Local puddle and liquefaction-related silt heaps on the road 6 days after the earthquake. b) Cracking in the fishery port due to the splitting and settlement of the coastal fill. Standing greens indicate that seawater has not come from the sea to the shore. Image locations are indicated in Figure 3.

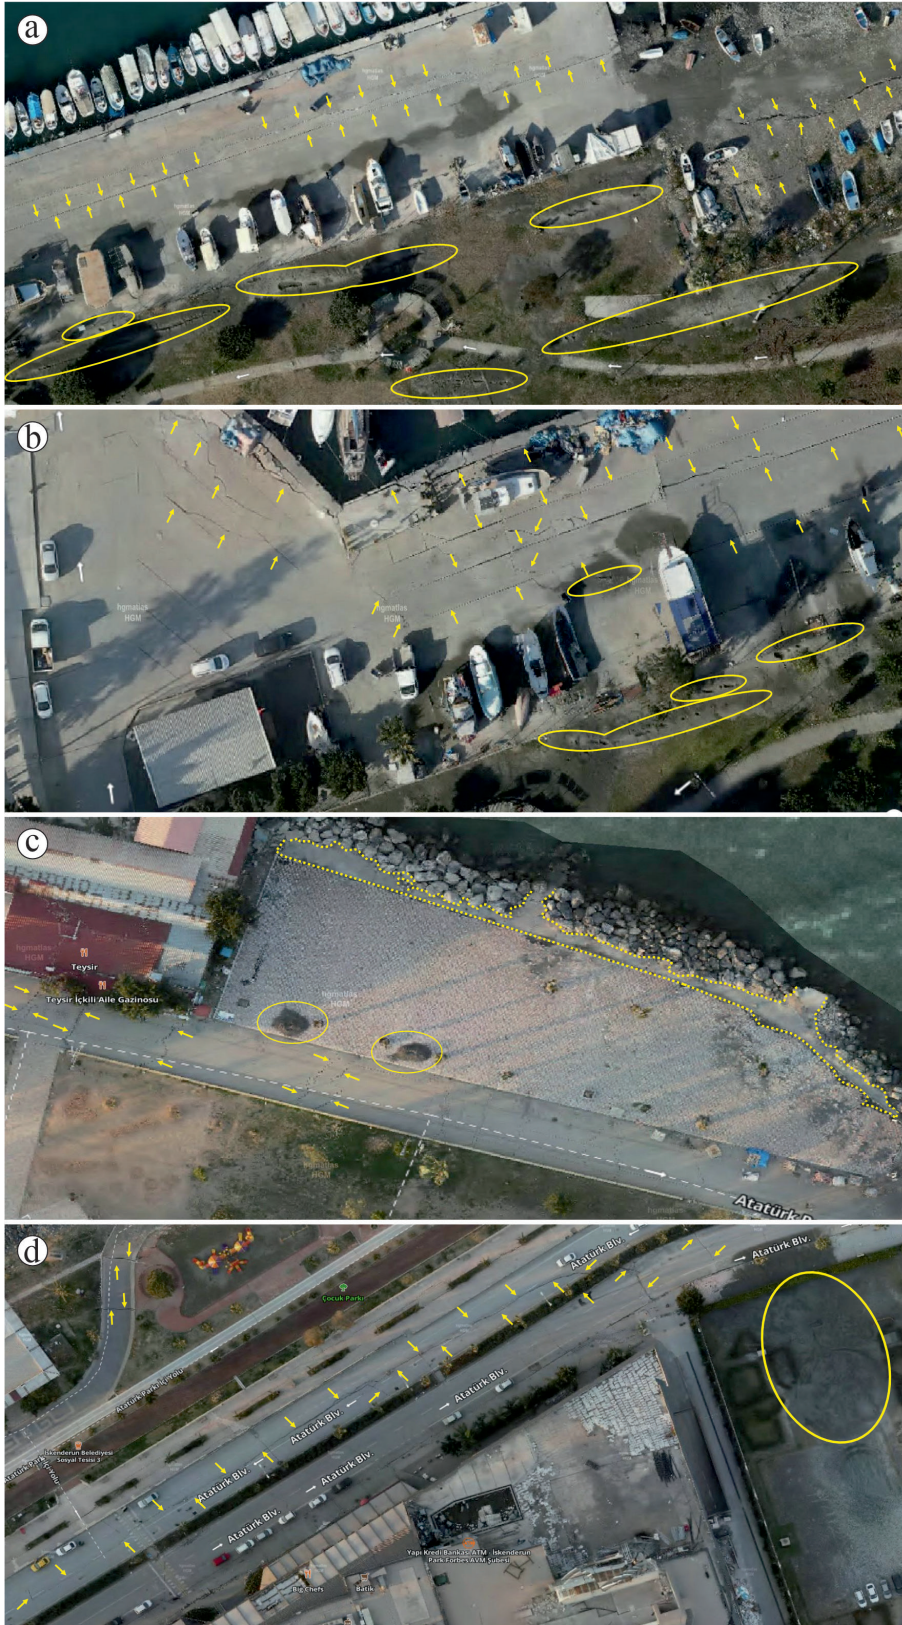
Figure 9. Yellow arrows show lateral spreading cracks and circles indicate sand ejecta associated with the main earthquake.

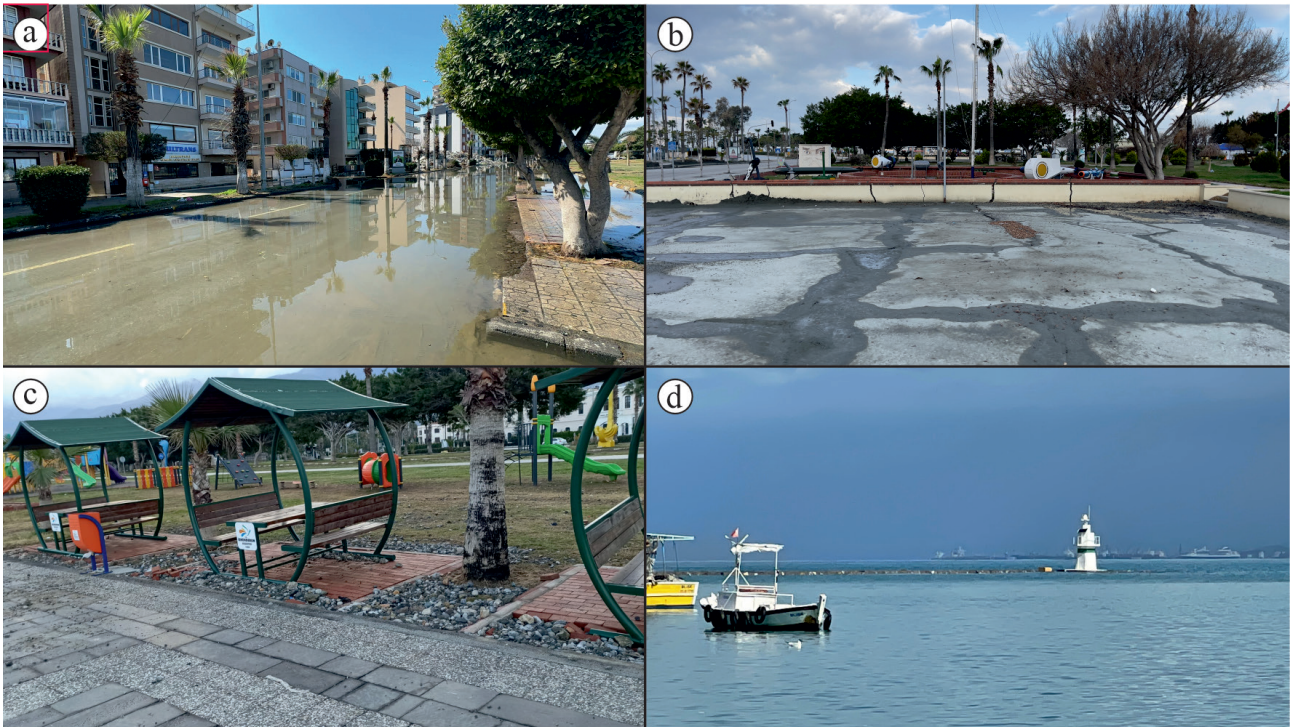
settlement was so extensive that the 1.7-m-high lighthouse descended to the water level, as depicted in Figure 11d. After the earthquake, new cracks formed, existing tensional cracks widened, and the stone fillings along the coastal zone dropped towards the sea. Unlike the event on February 6, there was no observed sand ejecta at the ground surface.

Figure 11b illustrates the widening of tension cracks. The lateral extension from the openings of five cracks on the wall, perpendicular to the shore, was measured as 34 cm (18 cm + 5 cm + 4 cm + 5 cm + 2 cm) over a 30 m dimension. This results in a lateral spread of around 1% from the combined movements of both the earthquakes on February 6 and February 20. In addition to the walls splitting/breaking, the surface water and wastewater collection channels that pass over the artificial fill zone and discharge into the sea were also damaged due to lateral extension.

Figure 11c shows how seawater intrusion into the park area caused the accumulation of gravel along the

grassy area. Due to the collapse of the coastal zone after the earthquake, waves piled up sea pebbles in the parks. Seawater infiltration along the opening cracks likely enhanced or triggered the lateral spreading and associated subsidence. After the earthquake on February 20, a cyclical or positive feedback mechanism led to subsidence-induced crack development and crack development-induced subsidence.

Figure 11. Coastal zone photos after the February 20, 2023 earthquake: a) streets inundated by seawater due to a combination of eastward blowing winds and ground subsidence; b) widening of the opening cracks (please refer to the white wall) along the park or filling zone indicating lateral spreading at approximately 1 percent; c) sea water intrusion into the park area and accumulation of gravel along the green zone; d) settling of the lighthouse into the sea associated with the subsidence of the coastal zone after the earthquakes.

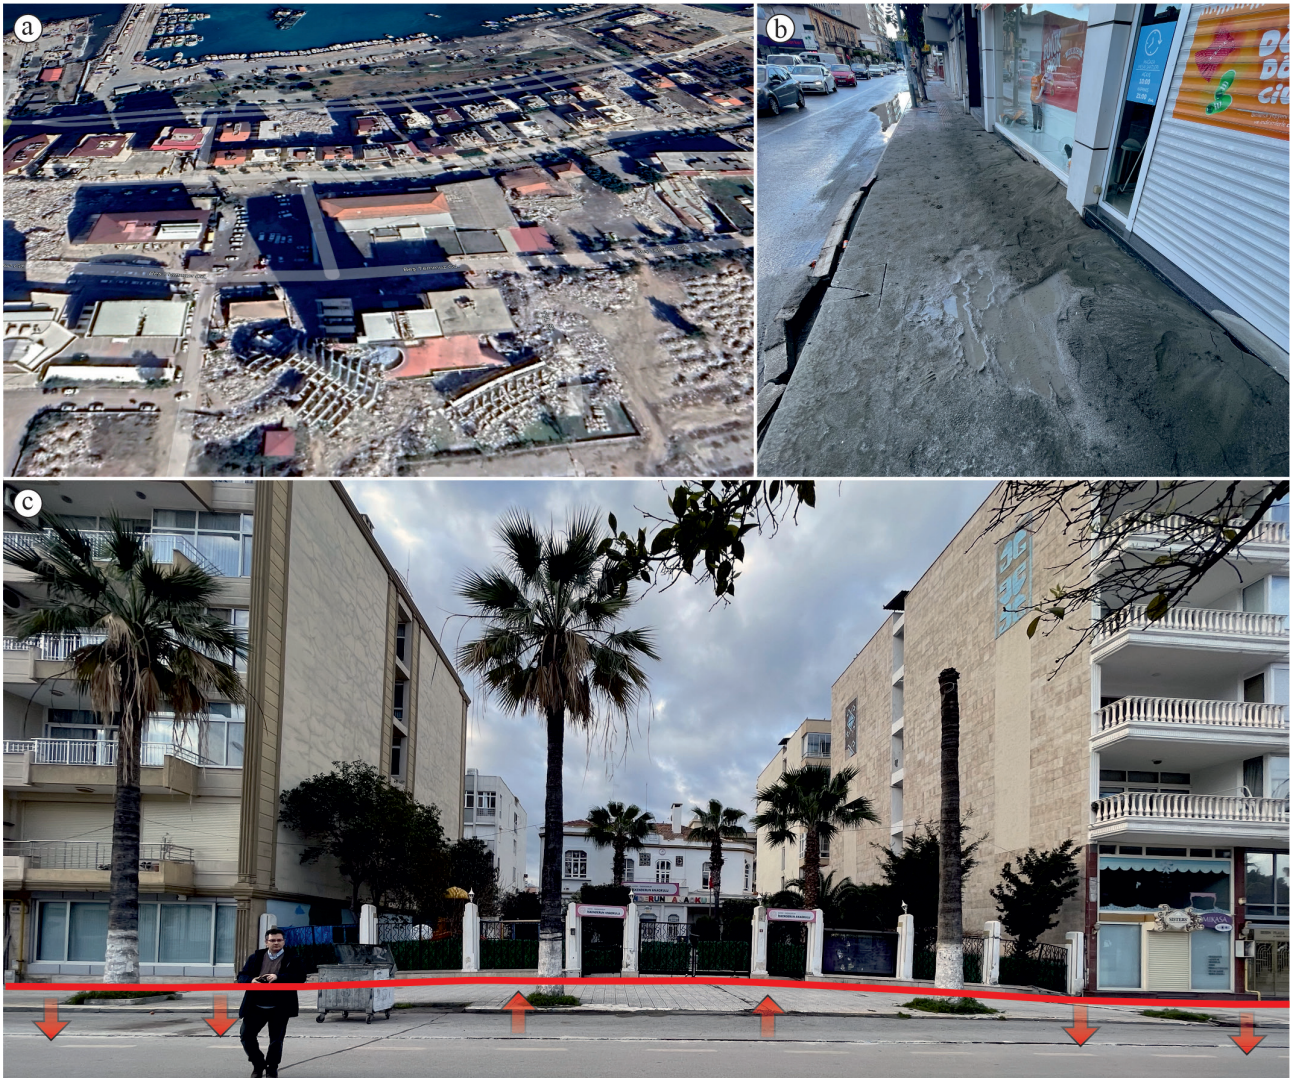
The presence of similar ground conditions along the shores of İskenderun, coupled with observations of settlements, water inundation, and building damage in areas with dense multi-story construction, underscores that the creation of high-rise buildings along the coast is the main reason for settlement and earthquake-induced disasters (Figures 13a–13c).

Figure 13. a) Collapsed tall buildings along the İskenderun Bay due to the soil liquefaction, indicating weak soil conditions along the sea shore (Google Earth picture). b) Liquefaction-related sand ejecta from the soil along the buildings. c) Relatively low subsidence area between two subsided tall buildings along the İskenderun coastal zone.

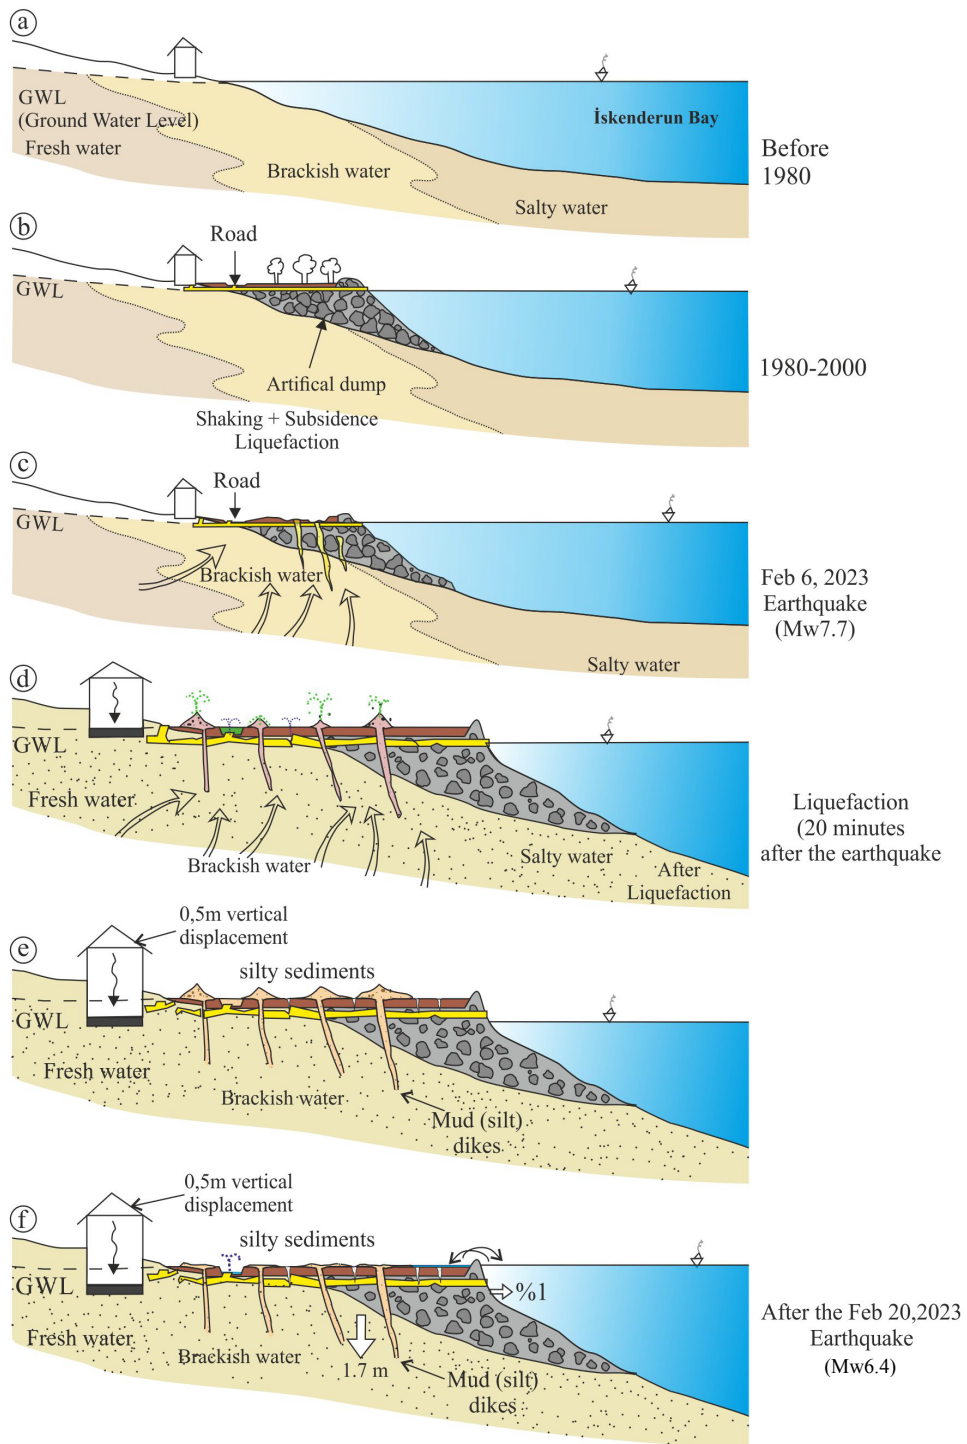
Figure 14 illustrates the ground settlement pattern, lateral spreading, groundwater and sand spouts, as well as streets filled with water and sand, observed on the shores of İskenderun after the earthquakes of February 6, 2023, and February 20, 2023. Sand dikes and sand cones related to soil liquefaction during and after the earthquake are illustrated in Figures 14a–14d). They are observed in both natural alluvium and areas with relatively thin artificial fill. The presence of opening joints and sand outlets, roughly parallel to the shore, provides clear evidence of seaward spreading. Coastal lighthouses or fishing port facilities were used as reference points for regional subsidence. Following the earthquake on February 6, 2023, the surface rupture passed 20 m east of the İskenderun settle-

ment. According to these reference points, the shores of İskenderun subsided by 0.8 m. Subsequently, due to ongoing aftershocks and the 6.4 magnitude earthquake that occurred 22 km east of the settlement on February 20, 2023, the subsidence accelerated, resulting in a total settlement of 1.7 m (Figures 14e–14f). In the case of lateral spreading, the extent of tension cracking was measured and its percentage was calculated. Particularly, based on the observed opening cracks in the walls perpendicular to the shore, it was determined that the lateral spread, which was 0.6 percent on February 2, increased to one percent on February 20. This serves as compelling evidence of the expansion towards the sea along the coasts. The settlement observed in İskenderun's coastal areas, along with the encroachment

Figure 14. a) Model depicting the development of the İskenderun coastal zone before the 1980s. b) Filling of the coastal zone extending up to 2 km in length and 200 m in width. c) Shaking and formation of sand ejecta associated with liquefaction water during the major earthquake on February 6, 2023 (Mw 7.7). The water originated from liquefaction and a broken sewage or water supply system, which flooded the streets (marked in green) after the earthquake and remained for five days before being pumped into the sea. Some buildings settled by about 0.5 m, tilted, or failed due to liquefaction in close proximity to the coastal zone. Coastal subsidence and lateral spreading were intensified, and seawater began to invade the green zone and fisherman port after the February 20, 2023 earthquake (Mw: 6.4).
