Response of water resources to the Kahramanmaraş earthquakes (MW 7.7 and MW 7.6) that occurred on February 6, 2023, on the East Anatolian Fault Zone (Türkiye)

Received: 24.04.2023

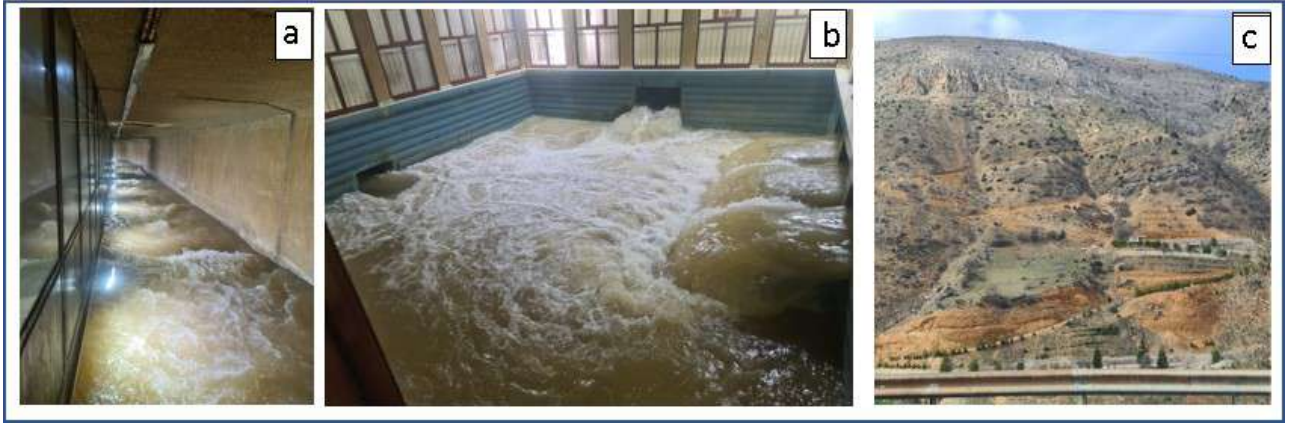
Figure 5. Derme karstic springs (a, b) and karstic limestone soil cover (c).

and small flow potential are discharged from different parts of the limestone fracture zone including the fault, bedding, and joint system (Figures 5a and 5b). The Derme spring was significantly turbid after the earthquakes and the water turbidity then started to decrease over a long period of time. It became turbid again after each aftershock. Based on field observations, karstic limestone covers brown-colored alluvial and terra rosa soils in this region, as seen Figure 5c. The long-term average discharge flow rate of the Derme spring was $2.7 \text{ m}^3/\text{s}$; however, the spring's flow rate increased after postearthquake shocks. It can be suggested that the increase in spring flow rate occurred with the addition of new fracture systems or by the cleaning of sediments in the fractures during earthquake shaking. Although the turbidity gradually decreased after the earthquakes, aftershocks were observed to cause turbidity to increase again in this water source. Looking at changes in the physical properties of the water, the electrical conductivity of the Derme spring was measured as $278 \text{ }\mu\text{S}/\text{cm}$ in 2011 (Dursun et al., 2016), and the postearthquake measurement was $293 \text{ }\mu\text{S}/\text{cm}$. In this case, a significant change in the amount of solid matter in the water was not observed, and it was understood that the turbidity did not affect the water characteristics due to the short water–rock interaction. Considering that the Derme spring meets the drinking water demands of about 750,000 people in Malatya, it is necessary to take measures to solve the turbidity problem.

- Sand filtration units should be included in treatment systems to remove the turbidity of karstic springs.
- To minimize earthquake damages, all transmission pipes should be replaced with high-density polyethylene pipes supported with full soil and sand backfill in the canal, and the ground should be improved in areas with a risk of liquefaction.
- The sewage distribution system in the study area, which was heavily damaged after the earthquakes, should be replaced with an earthquake-resistant and regionally monitored network.
- A sanitation monitoring system should be established to check the quality of water at the source and at the network units frequently.

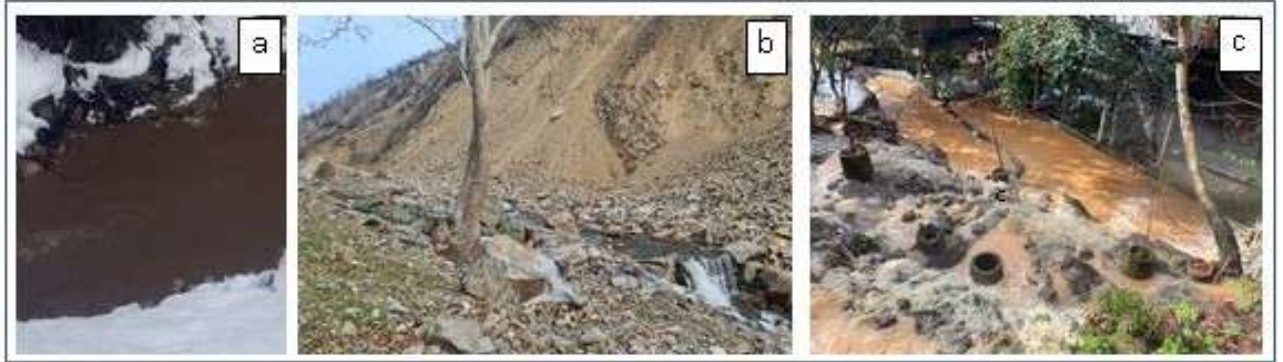
Another karstic spring is located in the town of Bahçe in the province of Osmaniye, Türkiye. The Bahçe spring, which originates from Eocene-aged clayey limestone, did not flow for about 3 to 5 h after the earthquakes and then started to flow with a very intense turbidity based on local people's reports (Figure 6a). The turbidity continued for a long time and it was observed that the spring still flowed turbid in March, the month of the field survey. The formation of the region begins at the bottom with

conglomerate and marl, where weak sequences of clayey and marl lithology play an important role in producing fine soil material that mixed with the groundwater after the seismic shocks (Figure 6b).

Another important karstic spring in the area is the Harbiye spring, which is discharged from the Cretaceous limestone in the Hatay region. The Harbiye spring is discharged from four different small-flow paths with a total flow rate of $0.8 \text{ m}^3/\text{s}$ (Figure 6c). According to a previous study, the limestone comprises very dense karstic conduits including bedding, fracture, and fault zones (DSİ, 2019). The Harbiye spring was turbid after the earthquakes and returned to a normal level within a short period of time. Based on geological features, the limestone is laterally and vertically in contact with the red-colored ophiolitic series and it is thought that the red-colored ophiolitic materials were poured into the saturated zone from the limestone fracture and crack systems during the earthquake shocks. For this reason, the turbidity occurred in a short period of time and the color quickly returned to normal.

Figure 6. Osmaniye Bahçe spring (a), conglomerate-marl lithology (b), Hatay Harbiye spring (c).

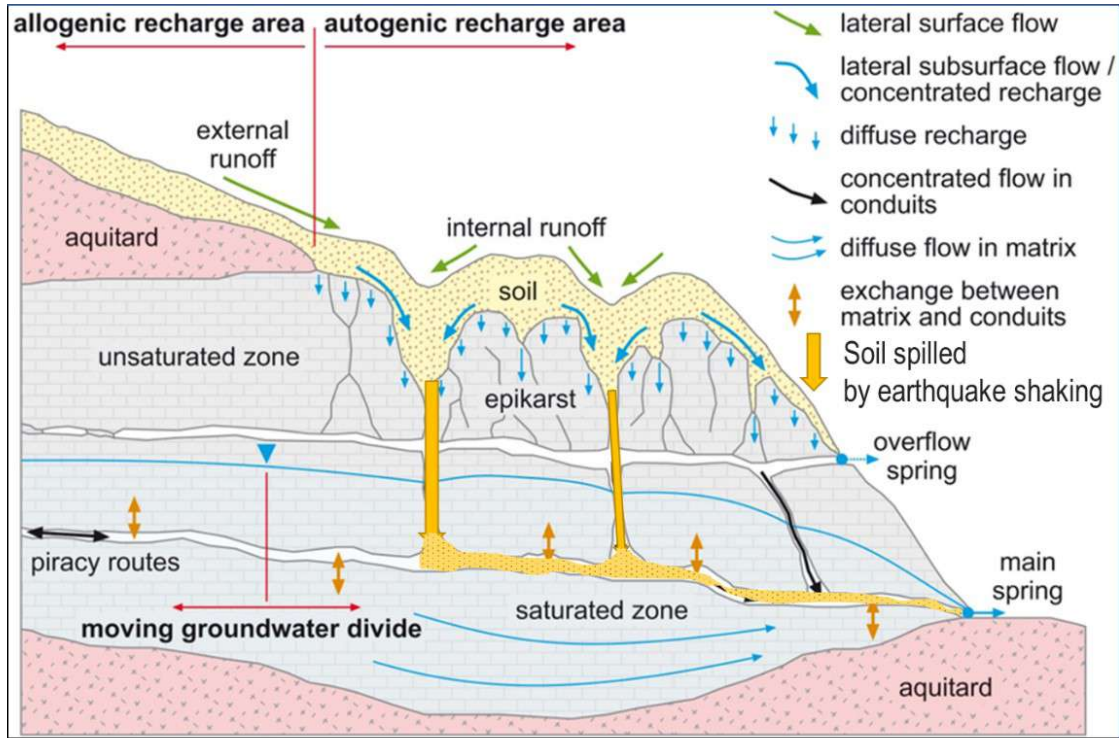
were detected in the production wells, but these ended after a short time. The general mechanism of turbidity in the karst system due to earthquake shaking is presented in Figure 7.

Figure 7. Conceptual model of turbidity mechanism in a karst system due to earthquake shaking (modified from Hartmann et al., 2014).

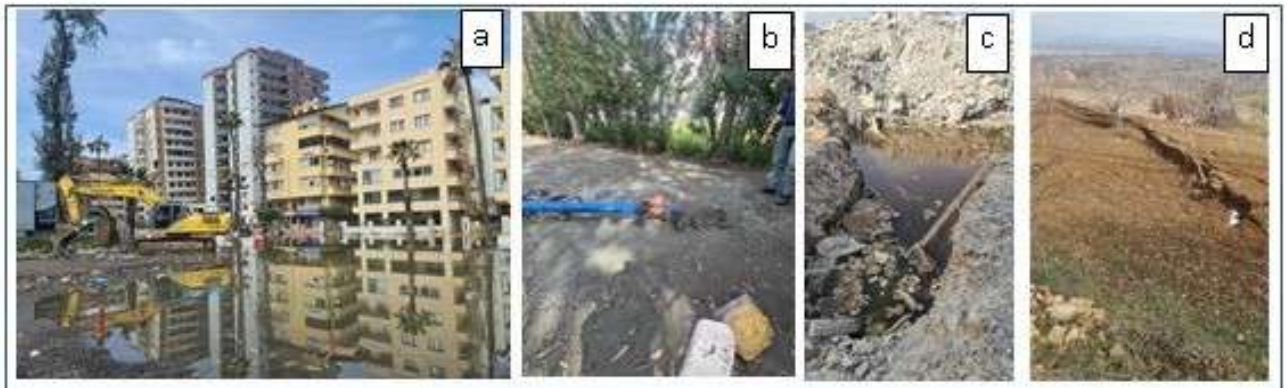
Another important aquifer system in the earthquake zone consists of alluvial aquifers. Groundwater is discharged by wells in alluvial aquifers and used for drinking and irrigation purposes. The liquefaction problem caused by the earthquakes in the plain where the fault zone extends caused significant damage to structures and wells supplying groundwater from alluvial aquifers. Significant settlement problems due to liquefaction occurred in the coastal alluvial aquifer very close to the seashore and many settlement areas were found to be filled with seawater (Figure 8a). In the field study, it was also observed that some wells in the alluvial aquifer were deformed and/or collapsed due to soil liquefaction (Figure 8b). In addition, there are densely built-up industrial and residential areas on the alluvial aquifer. The lines supplying drinking water to the cities in these regions and the sewage systems were found to have suffered significant damage. In areas with liquefaction problems, such as İskenderun, the treatment facilities were damaged and remained inoperable due to structural damages. In this case, it is thought that there is a risk of groundwater contamination in the alluvial aquifer, and especially in the drinking water and sewage system, as seen in Figures 8c and 8d.

Figure 8. Some structural deformations of the alluvial aquifer.

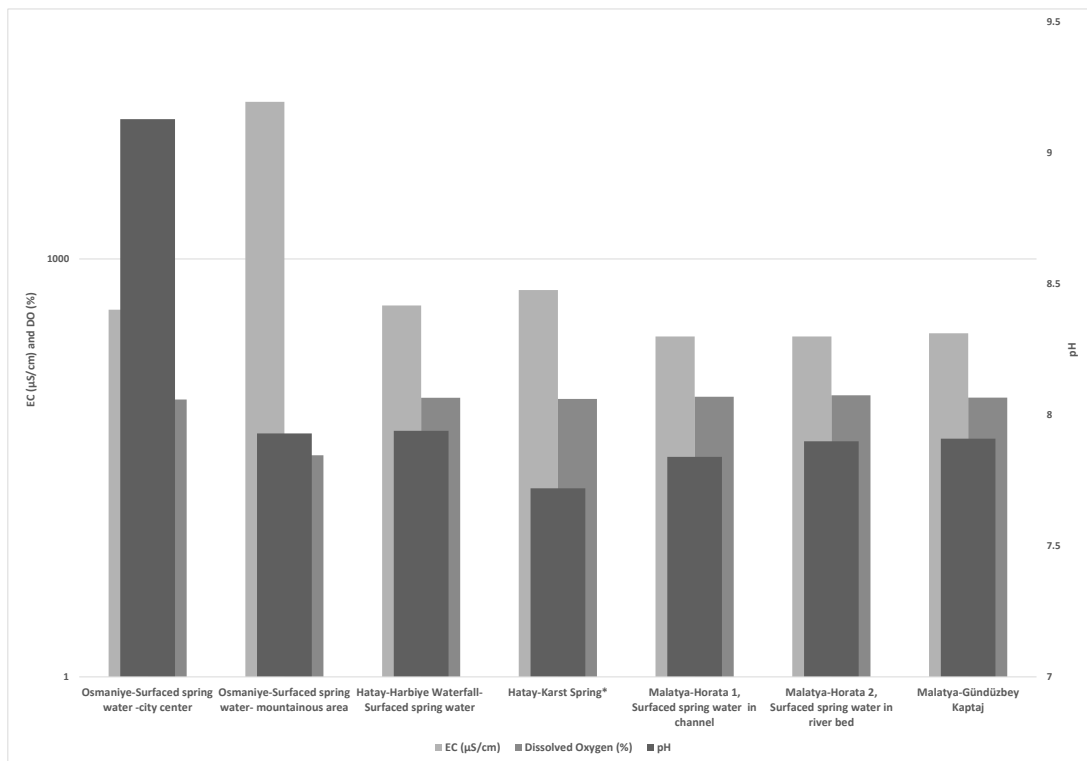
Türkiye, 2019). In other spring water samples, EC values exhibited Category A1 profiles. The pH and EC values of the spring waters from Osmaniye-Bahçe show that the origins of these waters are different, even though their distance from others is just a few kilometers. It was seen that spring waters from Hatay were of high quality based on the corresponding parameters, as were the spring waters from Malatya. The Horata 1 and Horata 2 samples showed identical characteristics; therefore, their source was understood to be the same (Figure 9).

Figure 9. Electrical conductivity, dissolved oxygen, and pH values of samples from springs. *: Physicochemical parameters were measured in the laboratory.

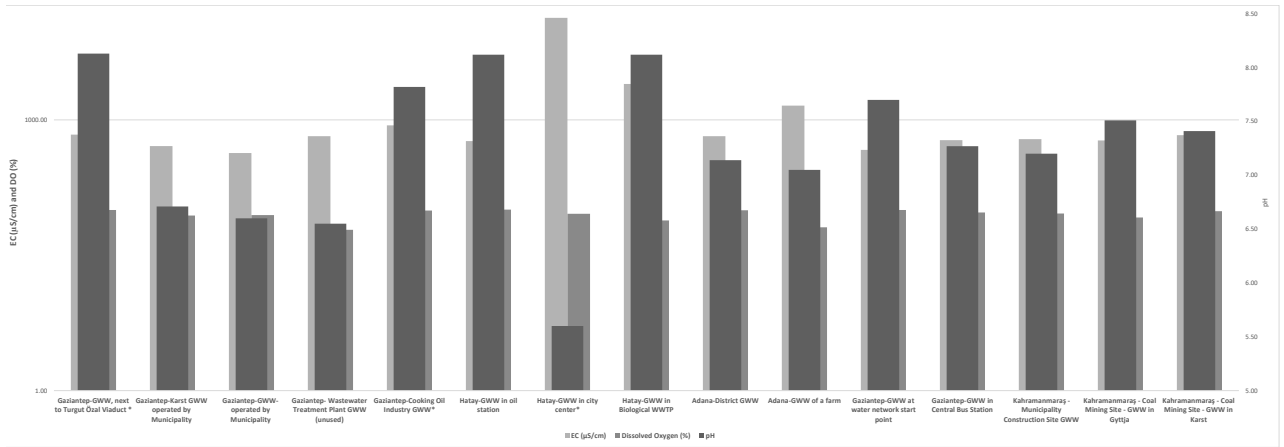
The only groundwater (GW) sample exceeding the Category A1 limit for EC was obtained from the Hatay city center with a level of 13,420 $\mu\text{S}/\text{cm}$, while the pH value of this sample was the lowest among all samples (Figure 10). The other GW EC levels were below the limit of 2500 $\mu\text{S}/\text{cm}$ for Category A1 waters. The oxygen saturation values of most GW samples were above 80%; however, the oxygen saturations of an unused well in the Gaziantep waste water treatment plant (WWTP) and another in the Hatay WWTP were measured as 60.5% and 76.8%, respectively. The pH values of groundwater well samples were in the range of Category A1 (Official Gazette of the Republic of Türkiye, 2019), except for a sample from the Hatay city center. Since the samples taken in Hatay were from a deformed alluvial aquifer, higher EC concentrations compared to samples from the other sites were detected due to liquification.

Figure 10. Electrical conductivity, dissolved oxygen, and pH values of samples from groundwater wells (GWWs). *: Physicochemical parameters were measured in the laboratory.

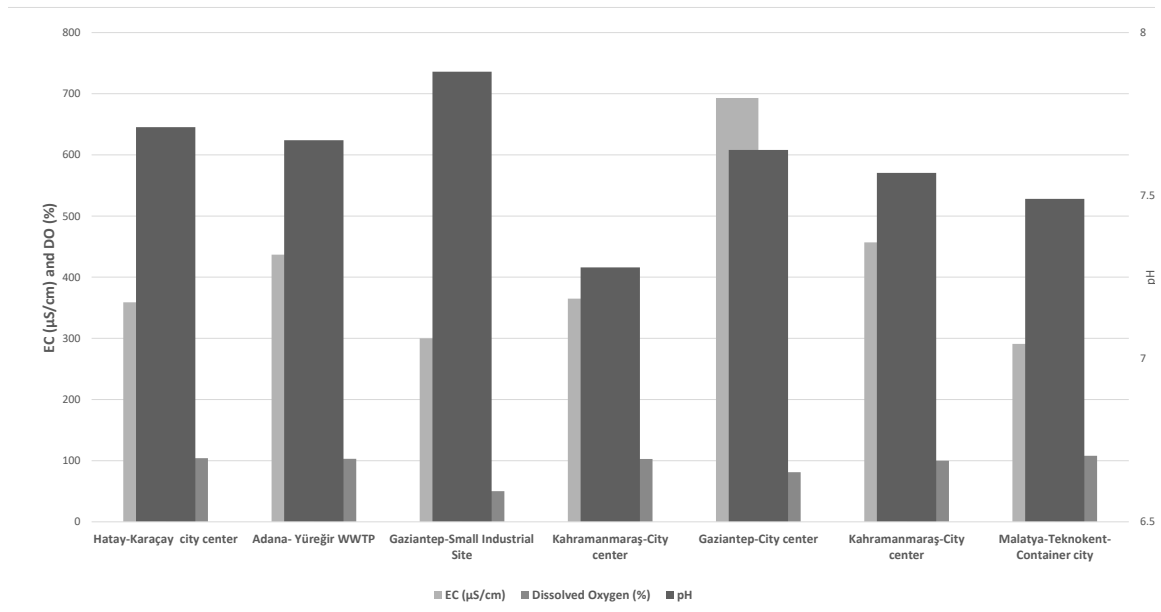
The EC and pH values of tap water samples were in the range of Category A1 waters. The oxygen saturation levels of these waters were above 80%, except for a sample collected from Gaziantep-Nurdağı, which was measured as 50% (Figure 11).

Figure 11. Electrical conductivity, dissolved oxygen, and pH values of samples from tap waters.

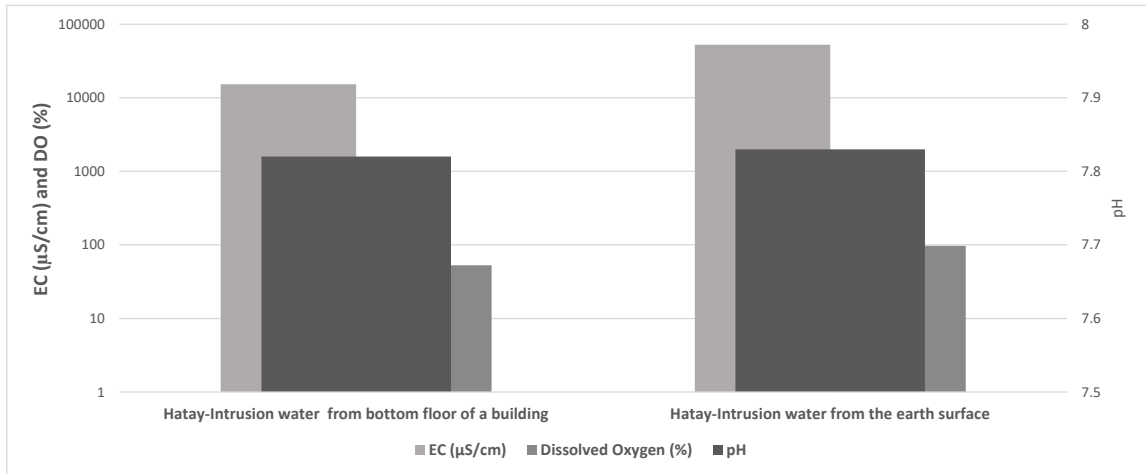
One of the intrusion water samples from Hatay-İskenderun was collected from sea water that had moved ashore; the electrical conductivity was measured as 52,500 $\mu\text{S}/\text{cm}$, reflecting a strong brackish water characteristic, while the sea water EC value was 58,000 $\mu\text{S}/\text{cm}$. This finding shows that this sample mainly comprised sea intrusion water slightly mixed with other less saline

water sources on the land. The oxygen saturation of the sample was 97%. Another sample from the bottom floor of a building showed lower oxygen saturation (53%) and a lower level of dissolved salts (15,250 $\mu\text{S}/\text{cm}$) (Figure 12).

Figure 12. Electrical conductivity, dissolved oxygen, and pH values of samples from intrusion waters.
