Traces of Ancient Earthquakes in Medieval Cities Along the Silk Road, Northern Tien Shan and Dzhungaria

Abstract: The evidence for earthquake destruction at medieval cities along the Silk Road from 800 A.D. to 1500 A.D. was examined using techniques of archaeoseismological mapping of architectural components at three currently excavated sites in southern Kazakhstan: Koylyk (Antonovka), Talgar (Talkhir) and Akyrtash, located on the northern branch of the Silk Road, Kazakhstan. This study revealed the following features of seismic activity at all three sites: (a) fractures cutting through a few adjacent bricks; (b) wall-tilts and collapses; (c) horizontal shift of bricks and stones; (d) rotation of stones and bricks. These types of destruction occurred at or very near the epicentres of ancient earthquakes. In some cases it was possible to determine the degree (seismic intensity), the direction of seismic-wave generation, and also the repetition of major seismic events. Since this portion of the Silk Route is along the northern edge of the Tien Shan mountain chain, one of the most active seismic areas of the Eurasian Continent, it is possible that abandonment of these cities was due

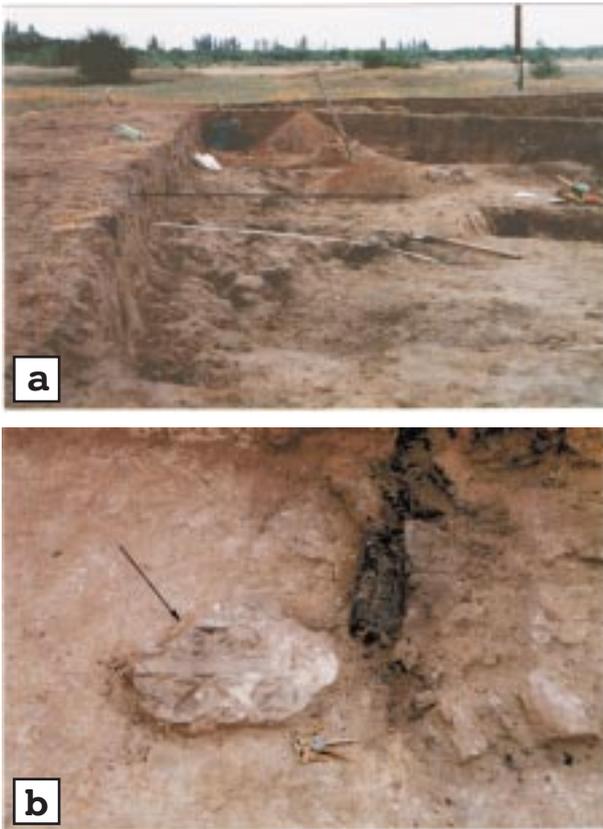
Figure 5. Collapse of *saman* walls in the wealthy farmstead at the Koylyk site. (a) SW external wall of the farmstead collapsed in NW direction. Bricks were thrown a distance of up to 2 m. (b) Preserved piece of a plaster from the inside wall.

was not damaged (Figure 5b), and fragments of the disintegrated wall lie on the floor. This suggests that the wall fell during a single event. The wall lacks indications of gradual disintegration of the *saman* due to the weathering effects of rain and snow after the abandonment of the building.

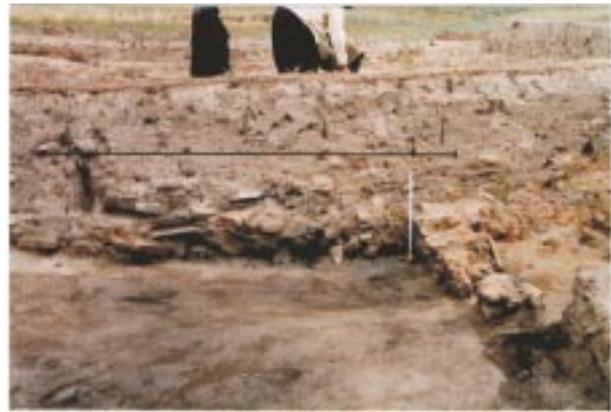
Figure 6. Tilt of the heating box pipe (*kan*) in a NW direction (room No. 10). A wall built above the pipe collapsed in the same direction. Bricks were thrown a distance of up to 3.2 m (shown by the arrow).

angle 68°), as is seen in Figure 6. A *saman* wall situated above the heating pipe also collapsed in a NE direction. In this case, the bricks were thrown a distance of 3.2 m (Figure 6).

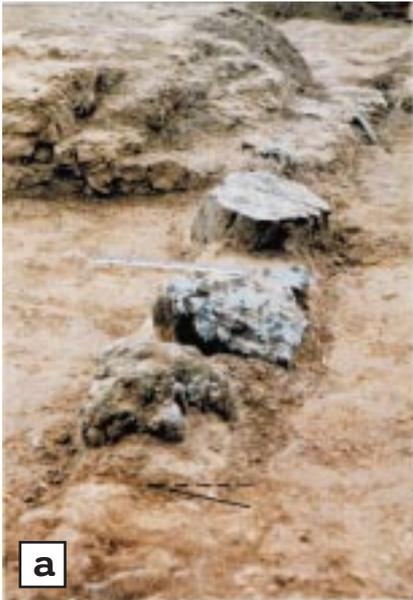
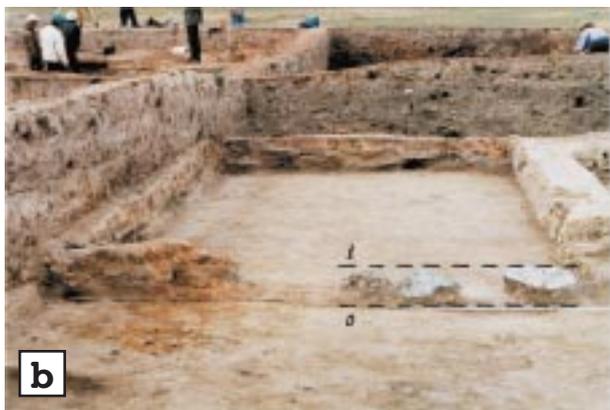
Figure 7. (a) Tilt of foundation stones (dip angle is 54° – 75°) in NE direction in room No. 4; (b) uplifted modern position of stone surfaces (dashed line 1), as compared with their original position (dashed line 0).

The foundation stones supporting the heating pipe in room No. 4 (II Quadrant) showed a similar pattern of collapse. The bearing of the pipe is 145° . The stones are tilted in a northeasterly direction, at angles 54° – 75° (Figure 7a). The present-day position of the foundation stones is 20 cm higher than the fragments of preserved pipe in the southern corner of the room (Figure 7b). Thus, it appears that these stones were thrown up and fell in a tilted position relative to their original placement.

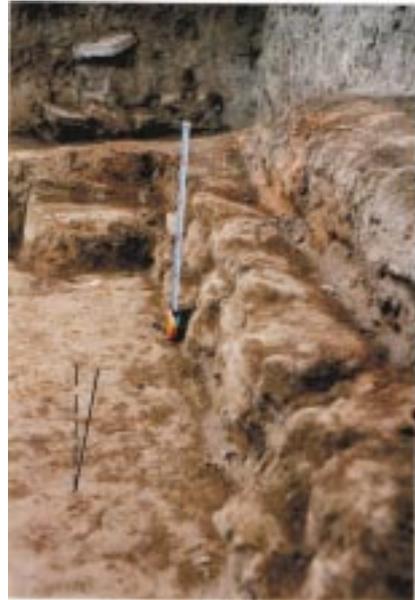
Figure 8. Shift and tilt in a northeast direction of lower course of masonry of *saman* bricks in room No. 16. Angle of declination of deformed wall is between the solid line (modern wall inclination) and the dashed line (originally vertical wall).

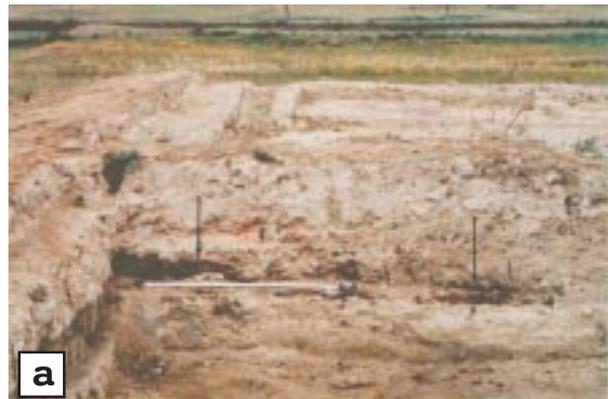
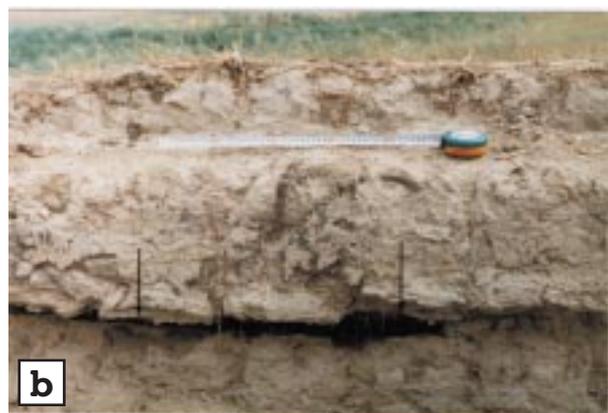
Figure 9. "Anti-seismic buffer" in the walls of the wealthy farmstead: (a) wooden log, (b) reed layer.

The ancient people may have recognized the problem of wall collapse due to seismic activity and tried to prevent wall damage; there is a method of construction in which a so-called “seismic buffer” is placed between the masonry walls of the farmstead. This “buffer” can be a

wooden log (Figure 9a) or reed layer (Figure 9b). We are of the opinion that the ancient builders used this construction technique to buttress their buildings against the frequent earthquake activity in this region of the northern Dzhungarian range.

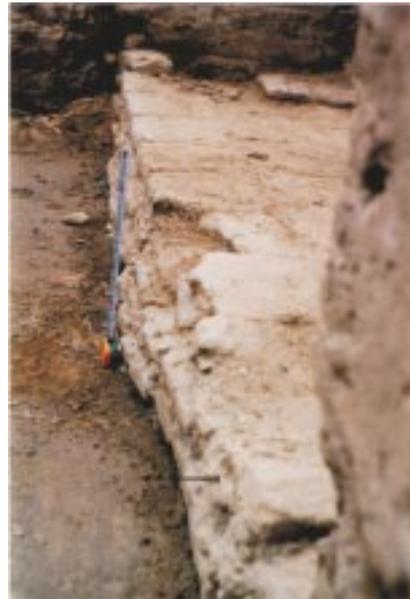
Figure 13. Shift of a lower course of bricks in a step at the temple entrance.

A step at the entrance to the main premises of the temple is constructed of four *saman* bricks in height. The lower courses of the bricks have shifted toward the SW (221°), forming a crack 11 cm (maximum) in length, when compared to the upper brick courses (Figure 13). The height of the step above the bottom of the excavated surface is 32 cm, and the azimuth for the horizontal placement of the original step is 131°. Since this step did not bear any load from above, the shift of the lower courses of bricks away from the upper courses must be due to seismic tremors of the ground below the building.

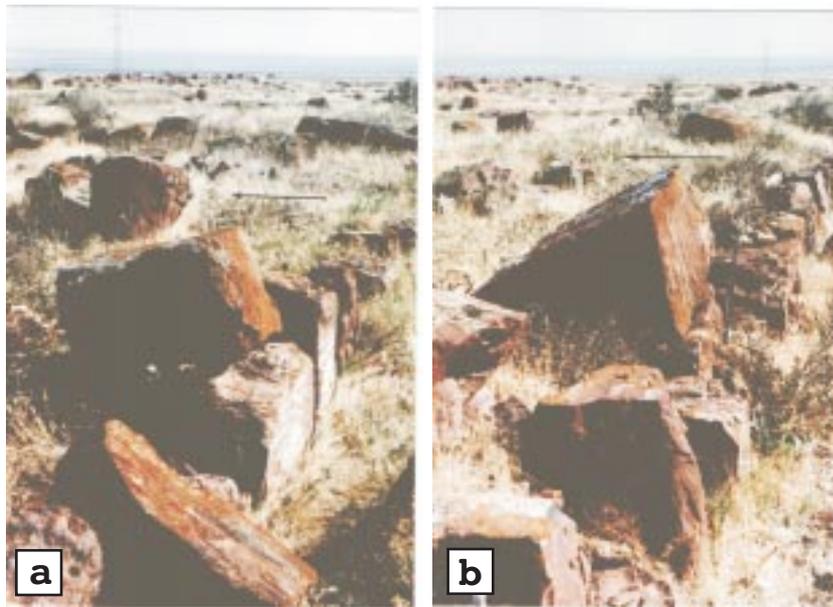
Figure 19. Tilt and shift of upper blocks in the walls, with arrows showing their directions. (a) northern wall of corridor No. 103 to the north; (b) southern wall of courtyard No. 6.

The preliminary study of the site has shown the existence of seismic destruction, for example, in the northern wall of corridor No. 103 (Figure 19a) there is evidence for the tilt and shift of the upper (second) block of the wall. The height of the preserved fragment of the wall is 115 cm. The size of displaced block is 85x70x50 cm. The block shifted and tilted northward (dip azimuth is 156°, dip angle is 60°) along an edge that is 12 cm in length. A bit eastward along the same wall another block
