Characteristics of the Weathering Zones Developed Within the Tuffs of the Midas Monument

TOPAL, TAMER and SÖZMEN, BURAK (2001) "Characteristics of the Weathering Zones Developed Within the Tuffs of the Midas Monument," *Turkish Journal of Earth Sciences*: Vol. 10: No. 2, Article 3. Available at: <https://journals.tubitak.gov.tr/earth/vol10/iss2/3>

Abstract: The Midas monument, an impressive cult facade located in the southern part of the Eskişehir province in central Anatolia, Turkey, was made within tuffs (white and pink), which now have deterioration problems. In this study, the depth and characteristics of the weathering zones that have developed in the white and pink tuffs have been investigated through thin-section studies, X-ray powder diffractometry, methylene blue adsorption tests, major-element analyses, and some index parameters. It has been determined that the feldspar minerals are mechanically fractured due to weathering. The tuffs contain small amounts of clay minerals. An approximately 1-cm-thick silica-rich zone has developed under a lichen cover on the pink tuff. The chemical weathering of the tuffs produces weathered zones, which are 4.5-cm-thick within the white

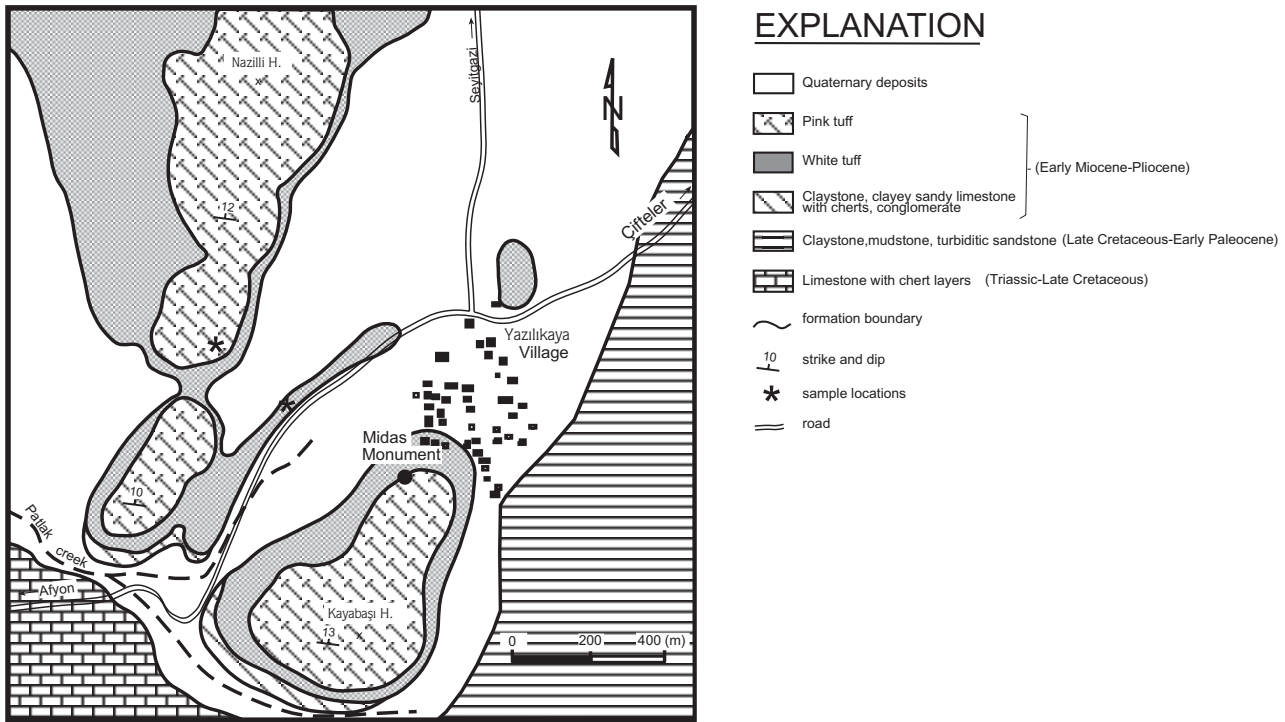
Figure 2. Geological map of the study area.

Geological studies in the region done by Özcan *et al.* (1989) and studies carried out by the present authors around the Midas monument reveal that limestone, claystone-mudstone-turbiditic sandstone, claystone-clayey sandy limestone-conglomerate, white and pink tuffs, and Quaternary deposits constitute the main lithological units exposed in the area. However, white and pink tuffs crop out widely around the Midas monument (Figure 2). The age of the tuffs is Early Miocene-Pliocene (Özcan *et al.* 1989). Within the monument, there are two different tuff units, and these units are distinguished on the basis of color and strength.

The lower part of the monument is made up of non-welded white tuff whereas the upper part of the monument is made up of slightly welded pink tuff. These

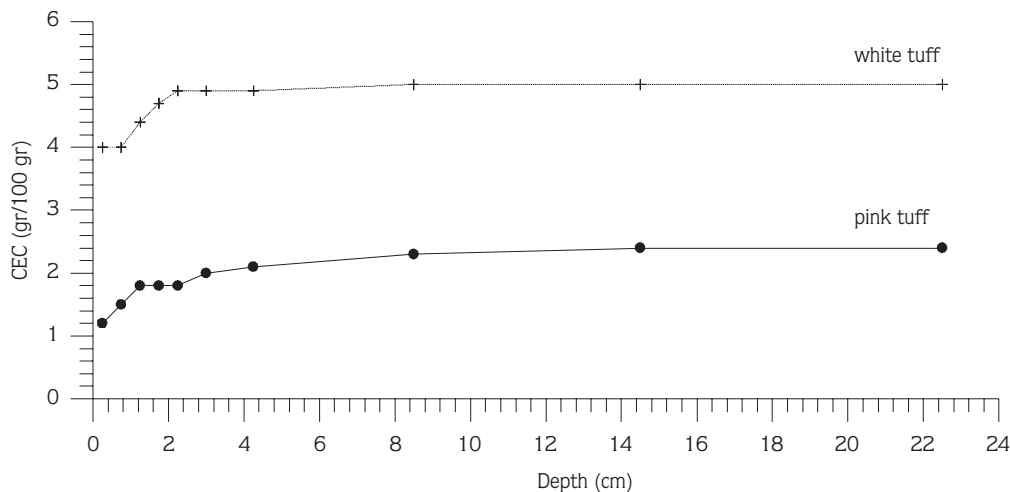
Figure 3. Variation of CEC for the white and pink tuffs.

cation exchange capacities (CEC) of the white and pink tuffs are given in Table 1. The CEC values are plotted with respect to depth in the horizontal direction (Figure 3).

According to the test results, the CEC values of the white tuff are low (Figure 3). Near the surface (0-1 cm), the CEC of the white tuff is 4 meq/100 gr. At greater depths, it increases to 4.9 meq/100 gr - 5.0 meq/100 gr. The low CEC values of the white tuff within the first 2 cm indicate that this zone has relatively low clay content. The CEC values of the pink tuff are very low compared to the white tuff (Figure 3).

Near the lichen-covered surface (0-1 cm), the CEC of the pink tuff ranges between 1.2 meq/100 gr and 1.5 meq/100 gr, and increases to 2.1 meq/100 gr at a depth of 5 cm, and 2.4 meq/100 gr at a depth of 23 cm. The low CEC values of the pink tuff within approximately the first 1 cm indicate that this zone has relatively low clay content.

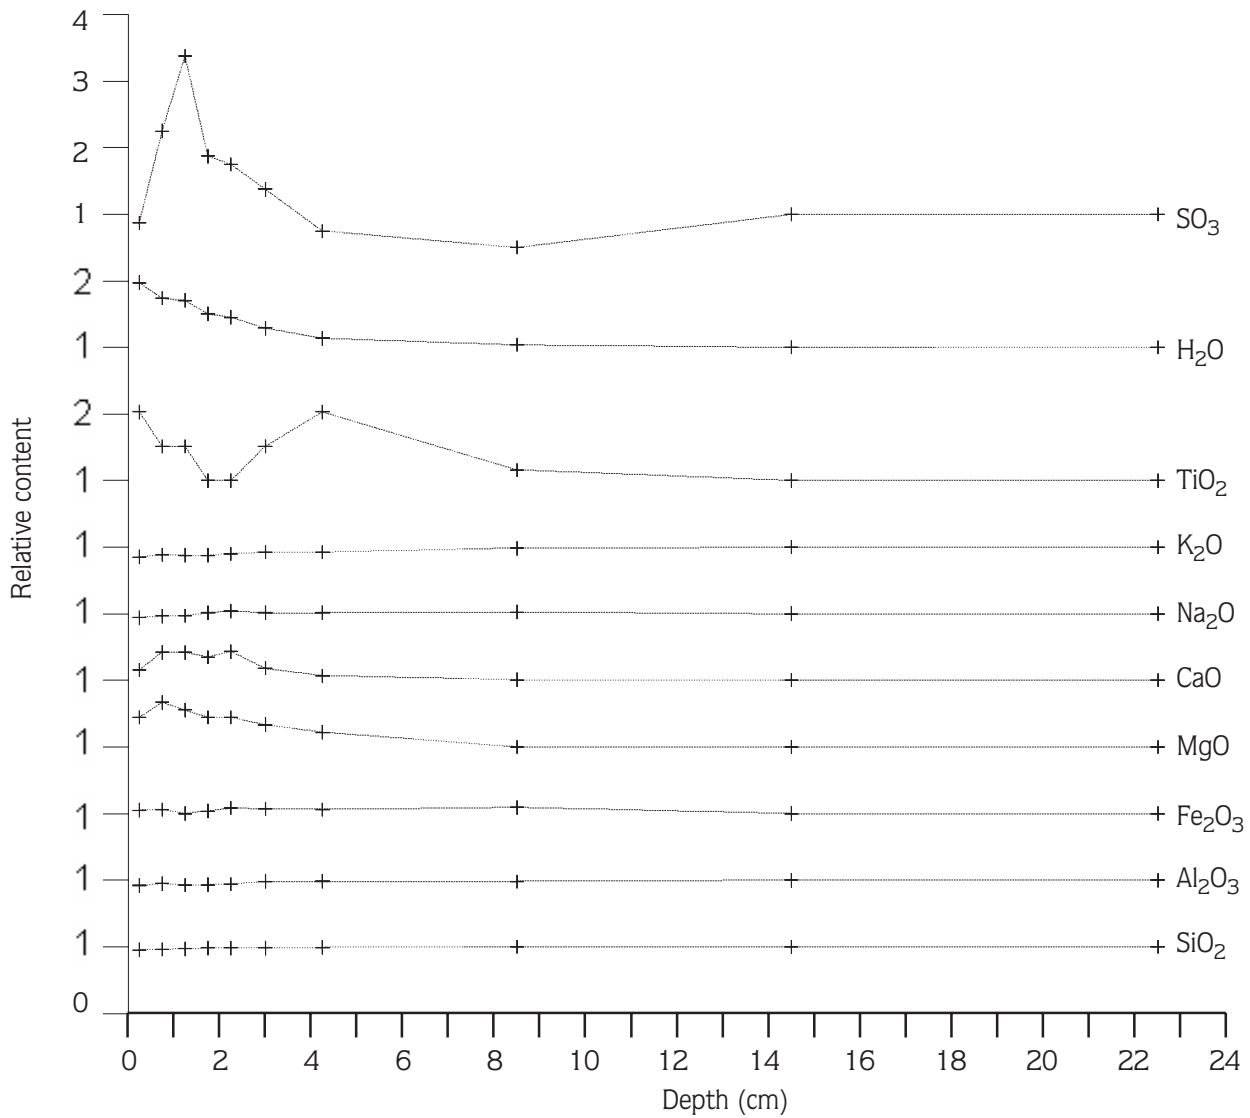
Figure 4. Relative concentration variations of the major elements in the white tuff.

The relative content variations with depth for each major element in the white tuff indicate that significant enrichment of SO₃, H₂O⁽⁺⁾, CaO and MgO occurs within the upper 4.5 cm of the weathered zone. However, TiO₂ fluctuates within the upper 8.5 cm (Figure 4). In the case of the pink tuff, a significant H₂O⁽⁺⁾ enrichment and minor CaO and MgO enrichments within the first 1 cm of the weathering zone were observed. The general trend of enrichment ceases at a depth of 2.5 cm. On the other hand, TiO₂, K₂O, Na₂O and Al₂O₃ are slightly leached out within the first 3 cm. SO₃ values fluctuate within the upper 8.5 cm (Figure 5).

Evaluation of these analyses indicates that the depth of weathering in the white tuff is about 4.5 cm from the lichen-covered surface, whereas it is mainly confined to the upper 1 cm and slightly extends to 2.5 cm from the surface in the pink tuff.

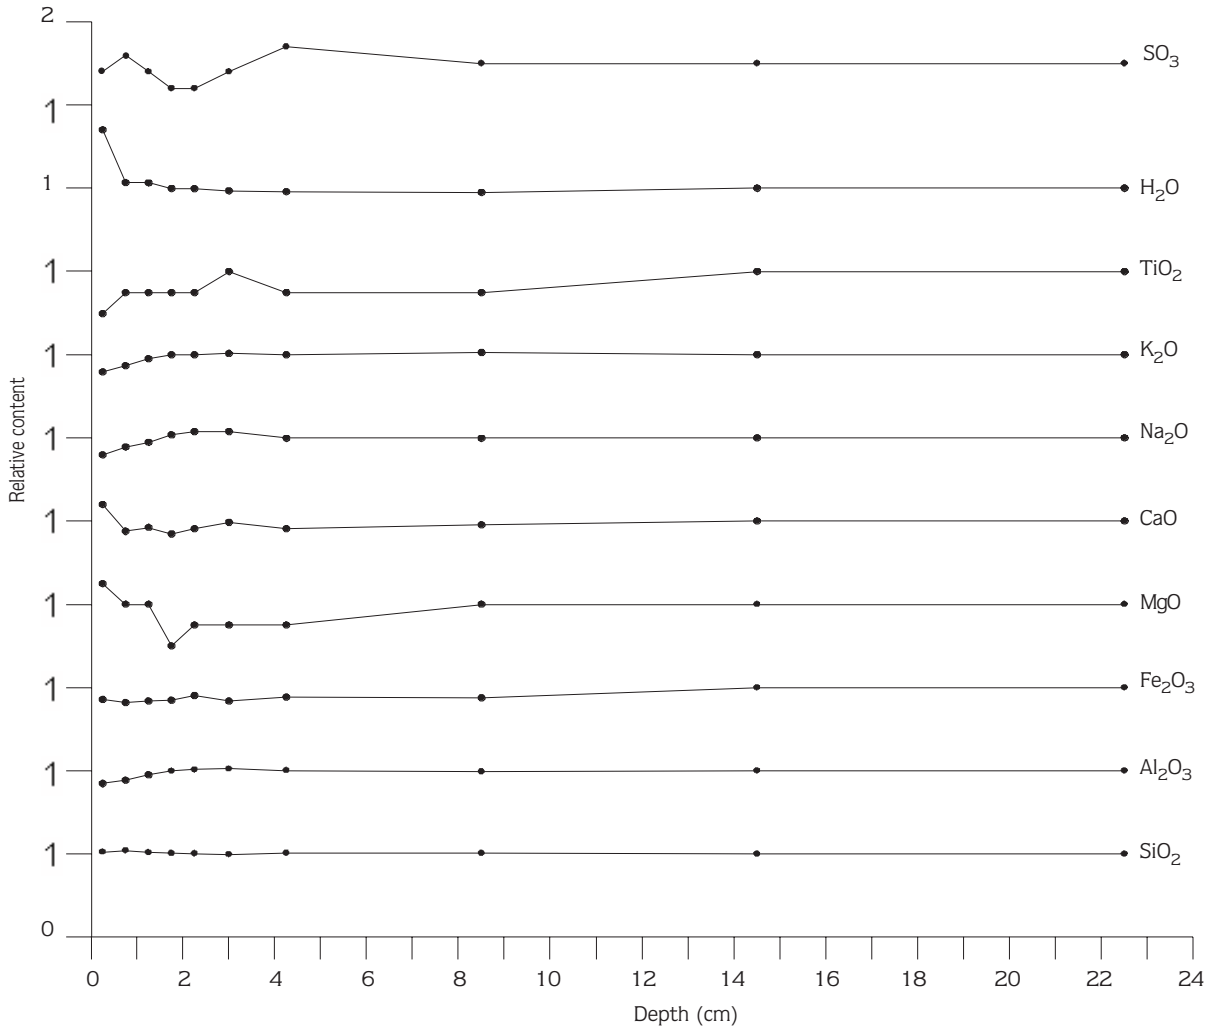
Figure 5. Relative concentration variations of the major elements in the pink tuff.

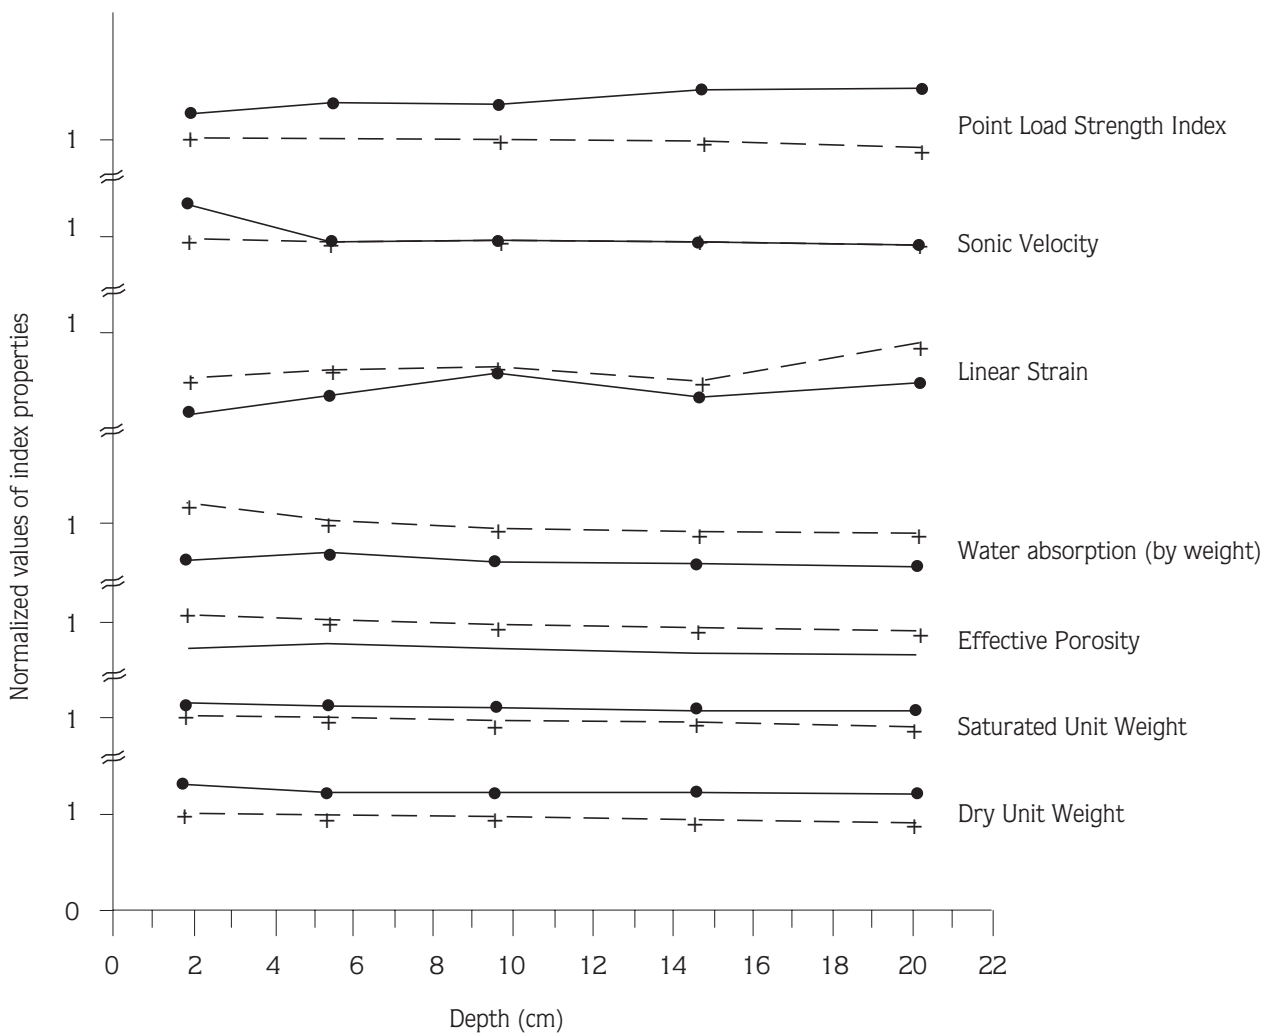
Figure 6. Variations of the index properties of the white (dashed) and pink (solid) tuffs.

weathering zones. Cube samples were prepared from five different depths in the block samples and the tests were performed on these samples in accordance with ISRM (1981), RILEM (1980), and TS699 (1987). The results are given in Tables 4 and 5, and the variations of the normalized values of the index properties of the tuffs are given in Figure 6.

Based on these tests, it was found that saturated unit weight, effective porosity, water absorption under atmospheric pressure, and the sonic velocity of the white tuff slightly increase within the upper 3.5 cm. However, no significant change in dry unit weight and point load

strength index was noted through the weathering zone. On the other hand, linear strain fluctuates with abnormally high values at a depth of 17-23 cm.

In the case of the pink tuff, no significant change in dry unit weight and saturated unit weight was detected. Effective porosity, water absorption, and linear strain of the tuff slightly decrease in the 0-3.5 cm depth interval, whereas sonic velocity increases considerably in this zone. This is due to the silica-rich zone that is present within the first cm. On the other hand, the point load strength index of the pink tuff slightly increases with depth.

The variations of the index properties with depth in both the white and pink tuffs are mainly confined to first 2.5 cm, but are not especially significant. This suggests a relatively fresh state for the tuffs. Due to the fact that linear strain is significantly affected by the heterogeneous nature of the tuffs, this parameter is not considered to be a good indicator in the assessment of weathering depths.
