Assessment of water pollution in a waste storage drainage area (a case study in Eskişehir, Türkiye)

Received: 01.11.2023 • Accepted/Published Online: 30.06.2024 • Final Version: 27.09.2024

Abstract: Before 2016, the Eskişehir city landfill was an irregular landfill. Since then, it has been transformed into a regulated landfill. This study aimed to investigate the presence of pollution in the landfill drainage area. For this purpose, water samples were collected from the landfill drainage area and the Kadirbey Farm Spring, upstream of the landfill area, during the rainy and dry seasons of 2021. Analyses of the heavy metal content, total dissolved soil (TDS), chemical oxygen demand, biochemical oxygen demand, pH, phenol material content, ammonia nitrogen content, and conductivity were conducted on the samples. Electrical resistivity tomography (ERT) measurements were also performed along the stream bed. According to Turkish Soil Water Quality regulations, the TDS concentrations of all the samples, except one, were lower than the limits for class 3 water quality. The conductivity limits were within the acceptable range for class 3 water quality. The pH of the water samples was alkal

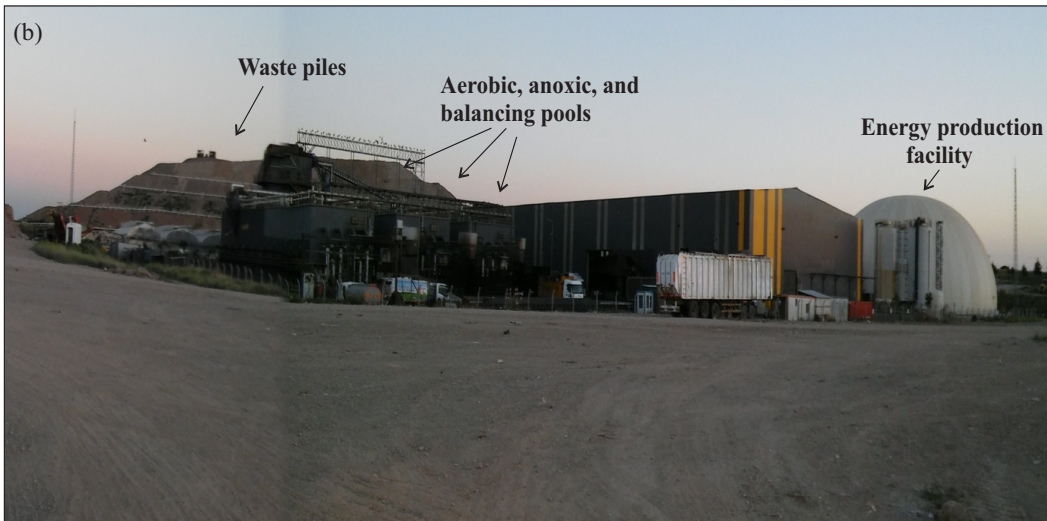
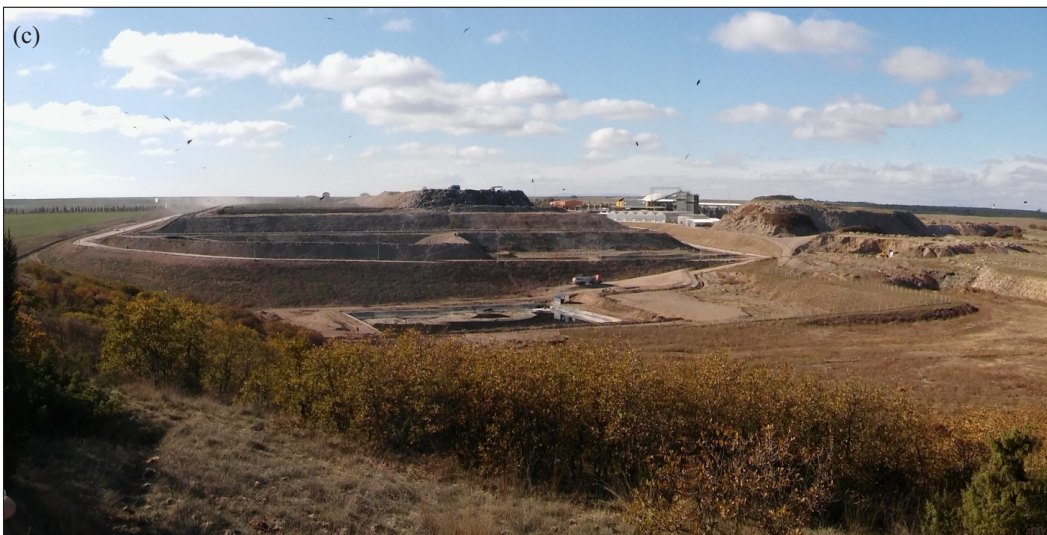
Figure 5. View of the Eskişehir regular landfill from (a) west to east, (b) south to north, and (c) north to south.

production of 10 MW of energy. The Eskişehir integrated facility accepts 800 t of domestic solid waste daily (Figures 4b and 5).

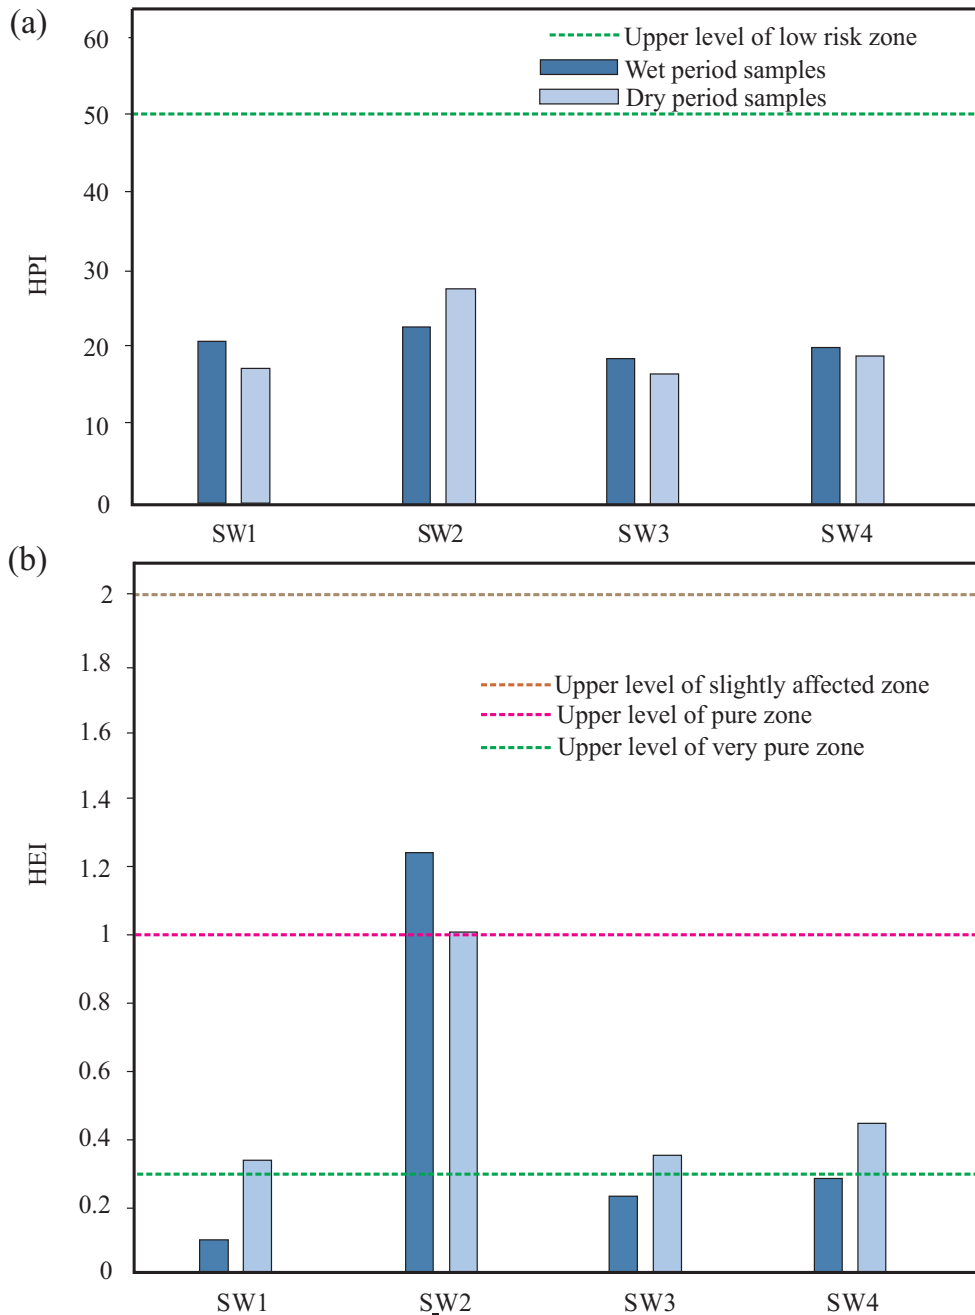
Figure 12. Pollution result histograms of the (a) HPI and (b) HEI.

Herein, the HPI and HEI were calculated using the ratios of measured heavy metal concentrations to the limits established in the TSWQR (2021). Figure 12a indicates that the calculated HPI values were under 100 in this study. The HEI gives the general evaluation of heavy metal risk in water concentration. Figure 12b shows that the SW1, SW3 and SW4 samples were in “very pure-pure” zone, where as SW2 sample was in “slightly affected zone.”

As shown in Figure 12a, all the samples were under the upper level of the low risk zone for both periods. The TSWQR values (for S_i values class 4, for I_i values class 1) were based on the calculations. The SW2 sample showed the highest degree in the dry period. The others yielded similar results. The HEI values were similar to the HPI values; however, the SW2 sample was in the slightly affected zone (class 3, Caeiro et al., 2005). The SW1, SW3, and SW4 samples were in the very pure zone in the wet period (class 1). These samples were in the pure zone in the dry period (class 2). These results showed consistency in terms of the TSWQR.

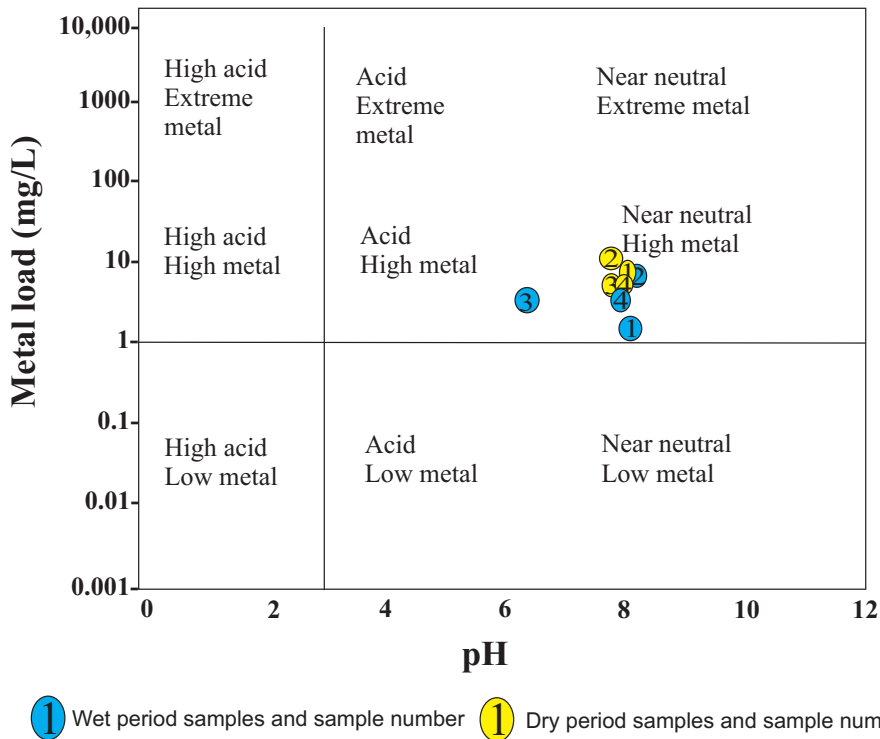
Figure 13. Water sample test results on a diagram of the metal load-pH chart.

Figure 13 shows the relationship between the total metal content and pH. All the samples were close to the near neutral, high metal location, except the SW3 sample, which was between the near neutral-high metal and acid-high metal locations. A high metal content in water samples can pose serious health risks for consumers (Ficklin et al., 1992; Caboi et al., 1999).

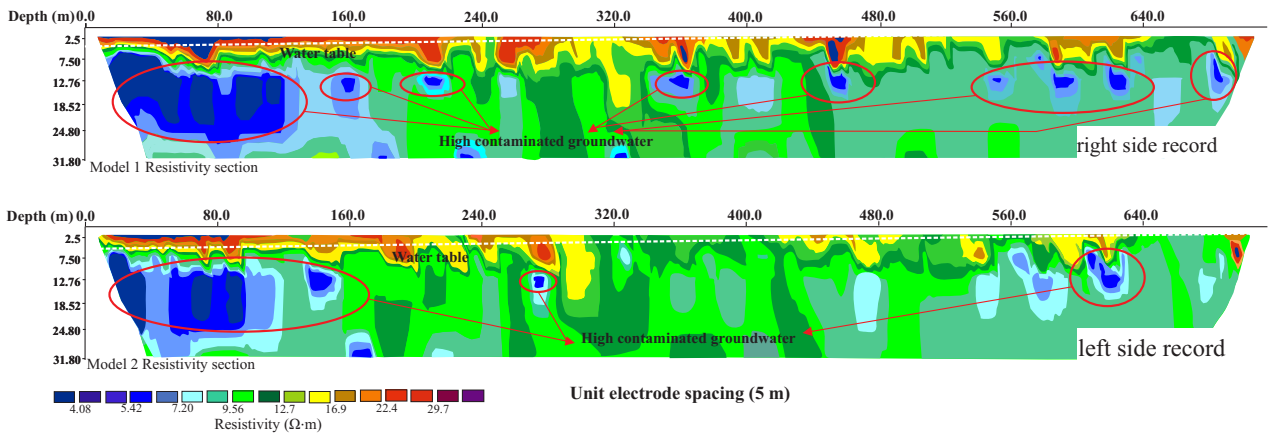
Figure 14. Right- and left-side ERT measurements between BH2 and BH1.

The right- and left-side ERT measurement profiles are given Figure 14. It was observed that the resistivity records taken on the right-side ERT measurements were slightly different, especially at near-surface levels. The ERT measurements emphasize a slight difference between the right- and left-side records regarding contamination. The measurements can be grouped as low resistivity values ($<5 \Omega \text{ m}$) significantly observed in the region close to the landfill area, moderate resistivity values (10–20 $\Omega \text{ m}$), and relatively high resistivity values as a thin layer close to the surface ($>20 \Omega \text{ m}$). Soils with low resistivity are notably laterally wider, particularly in the regions close to the landfill area, up to 130 m. Intensive contamination was remarkable between 40 and 80 m horizontally. The contamination was thought to be caused by the accumulation of leachate water. Highly contaminated zones like a plume which disconnected with each other. The shapes and volumes of the highly contaminated zones got smaller toward the BH1. The presence of sandy, silty litology observed at surface in the region caused the leachate water to flow to deep levels due to their high permeability. Low resistivity values were rarely observed in the continuation of the measurement zone away from the landfill area. Conversely, areas with high resistivity were monitored at a narrow depth, for almost the entire measurement line at near-surface levels. The recording of high resistivity values near the surface may be related to surface water flow throughout the landfill to

BH1 (Ganiyu et al., 2016). Left-side records show the high contamination observed at the deeper levels near the landfill area. The levels are considered to be saturated with leachate

water, distinguished by low resistivity values, and are still remarkable but spread up to 95 m horizontally from the landfill area.
