Soil liquefaction and subsidence disaster in İskenderun related to the 6 February 2023 Pazarcık (Mw: 7.7) and 20 February Defne (Mw: 6.4) earthquakes, Türkiye

Hüseyin ÖZTÜRK^{1*}, Craig A. DAVIS², İbrahim KUŞKU¹, Süleyman DALĞIÇ¹, Cem KASAPÇI¹,
Muharrem Alper ŞENGÜL³

Abstract: The Mw 7.7 Pazarcık earthquake on February 06, 2023, struck southern Türkiye, causing typical liquefaction along the shores of İskenderun Bay. This liquefaction was characterized by lateral spreading, subsidence, and flooding. Subsidence-triggered sand ejection, water flows, and opening cracks were identified in areas spanning approximately 2 km in length and 300 m in width.

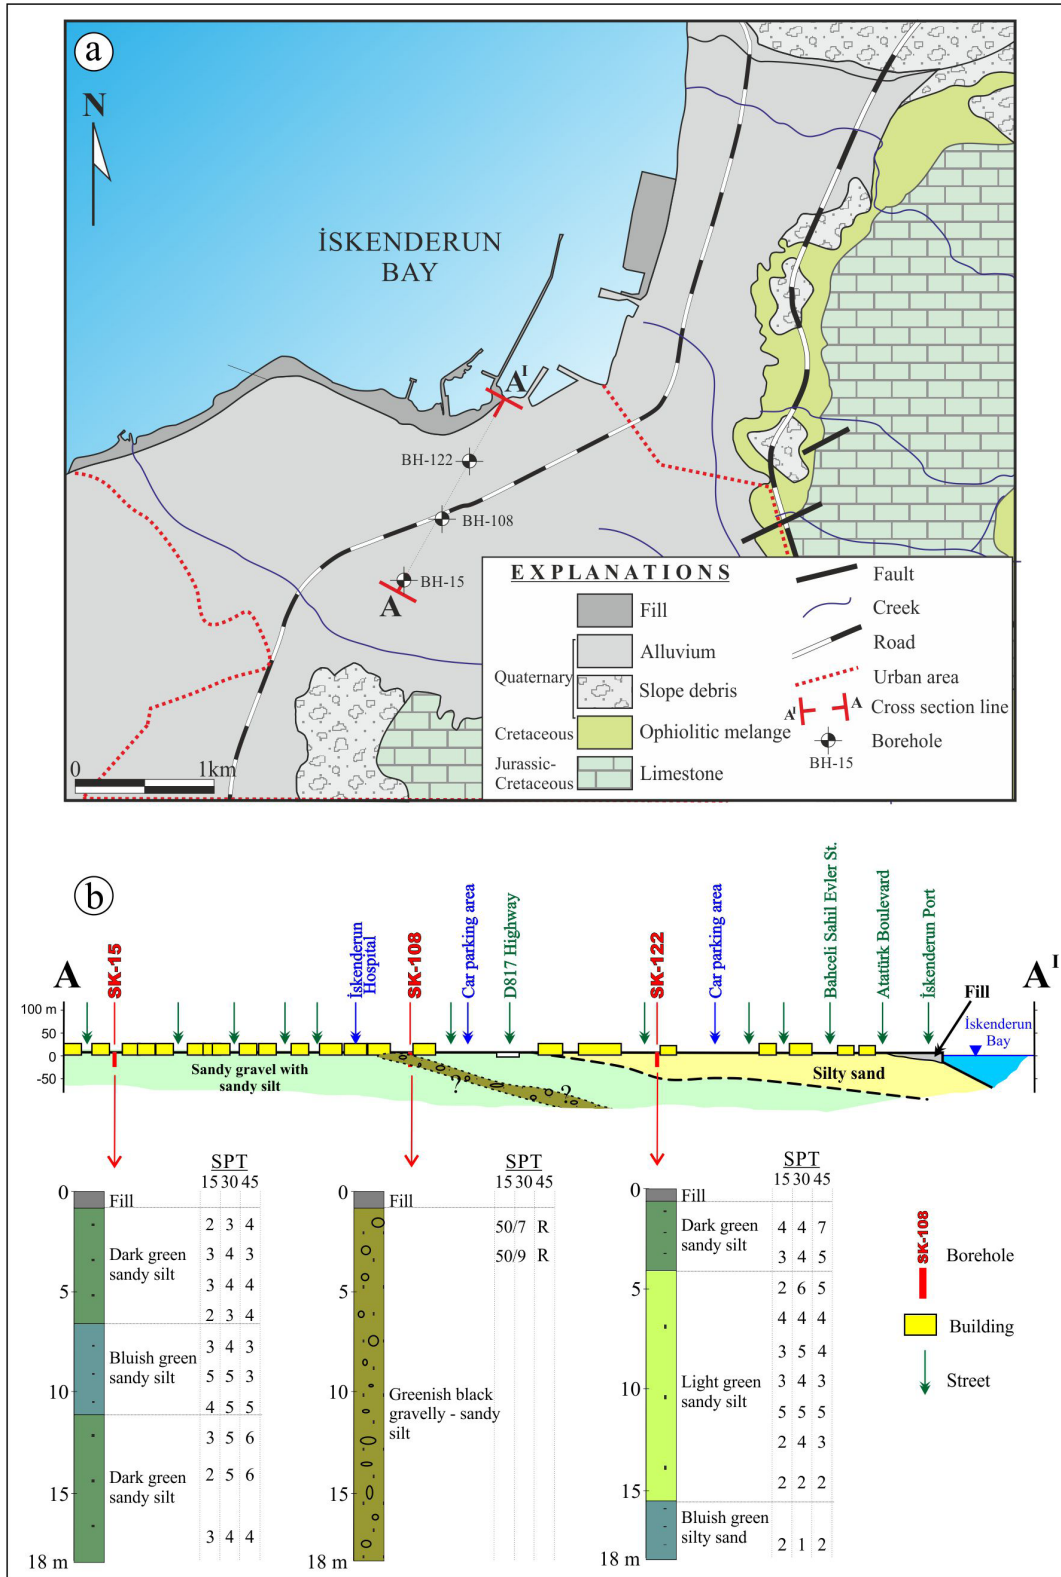
Figure 2. a) Geological map of the İskenderun coast depicting alluvial plains, creeks flowing into the sea and the areas filled in after 1970. The filled coastal zone materials are approximated on the geological map. b) Correlation of the geotechnical borehole logs along section A-A', as shown in Figure 2a, illustrating weak alluvial soil conditions characterized by low SPT values.

Soil investigations in İskenderun were conducted by Denge Engineering Company (Denge, 2010), revealing through geotechnical tests and geological-geophysical studies that the alluvial soils have the potential to liquefy. Figure 2b illustrates the presence of very weak alluvial soil conditions, characterized by very low N30 standard penetration test blow count values ranging from 3 to 11 down to a depth of 18 m in three bore holes. Deeper borehole investigations have also indicated the presence of sandy gravel layers up to 40 m thick in the silty sand sediment (Denge, 2010). The İskenderun coastal plain has a shallow groundwater table, located 1–3 m below the ground sur-

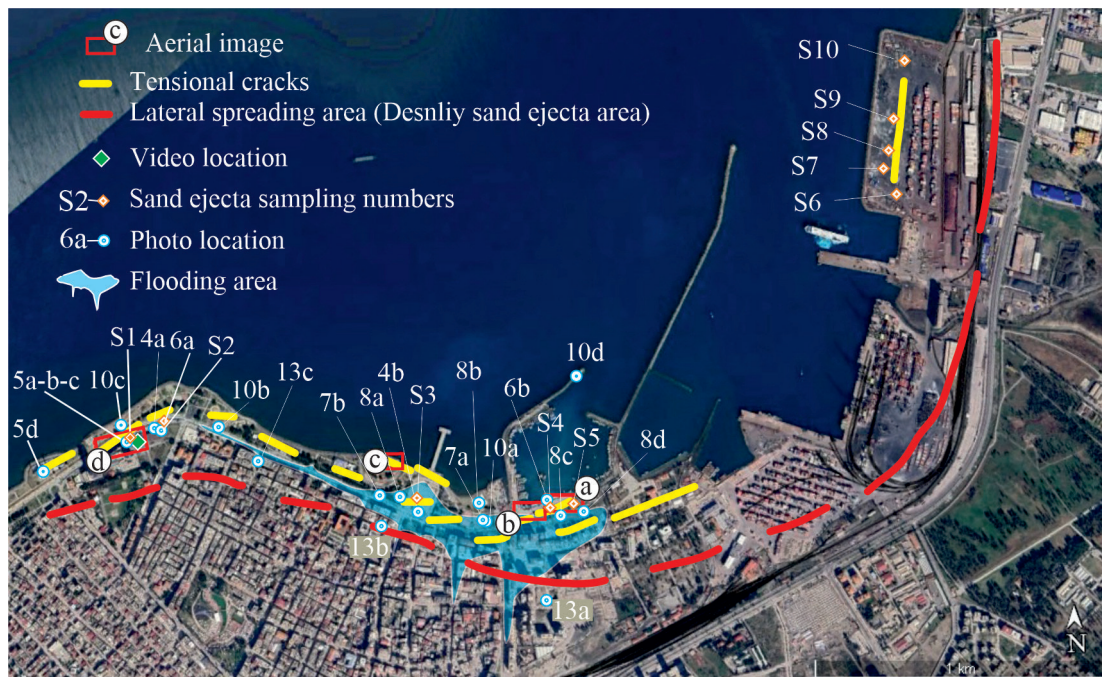
Figure 3 displays a satellite image of the study area, indicating the locations of tension cracks, the boundary of observed lateral spreading, the area of surface flooding, and locations of photographs, a video, and sand ejecta sampling. Following the Pazarcık earthquake, it was observed that the artificial fill settled and spread laterally. Liquefaction-induced sandy water jets were ejected onto the ground surface, which then collected and flooded the streets in the areas shown in Figure 3. In Figures 4a and 4b, images depict water inundating the streets after the 06 February earthquakes, a situation described by the national media as being associated with seawater inundation, without any coastal observation. Site investigations identified the silty sand boils that were ejected during the

Figure 3. Map showing flooded areas following the Mw: 7.7 Pazarcık earthquake, featuring opening cracks (in yellow), zones of pronounced liquefaction and lateral spreading (highlighted by red lines), sampling sites for sand ejecta, locations of the photographs and video records utilized in Figures 4 to 8, and locations of aerial photos in Figures 9a to 9d.

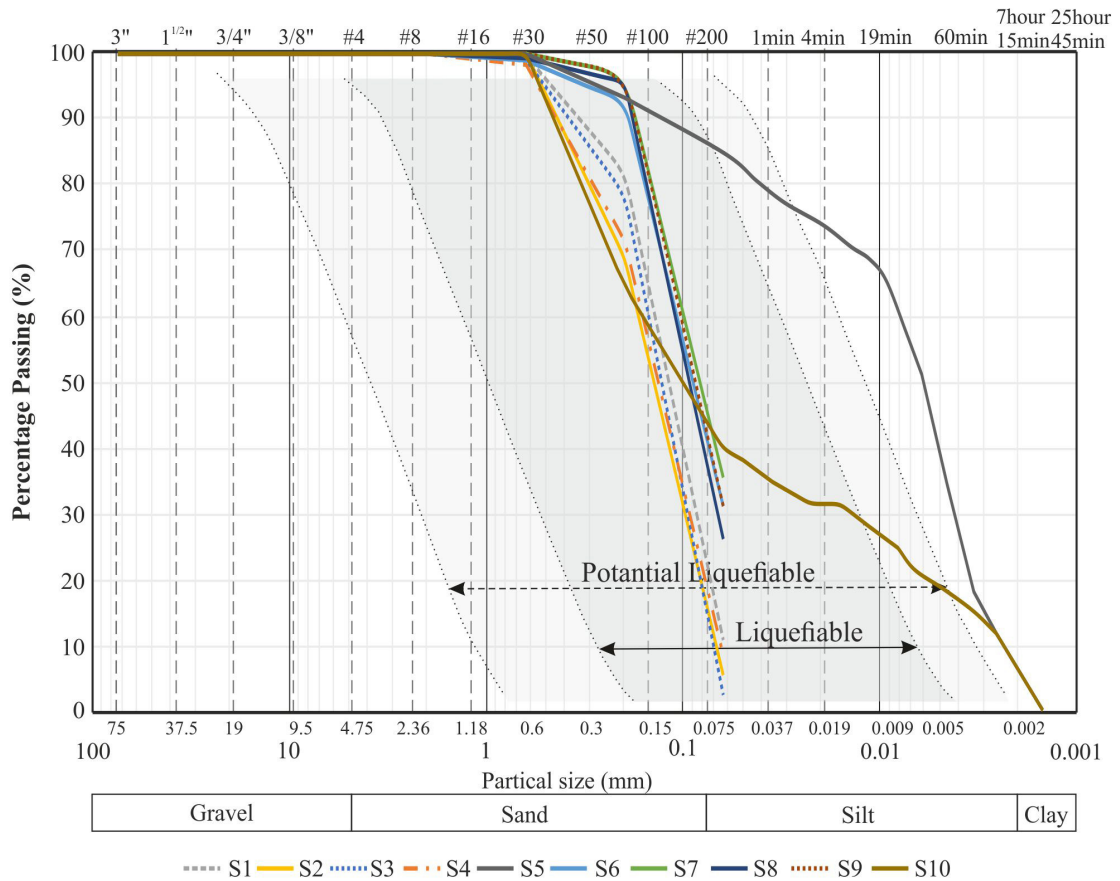
formed, it was observed that 8 samples fell within the liquefiable range, while the remaining 2 samples, containing higher levels of clay and silt (S10 and S6), were outside this range (Figure 10). Similar soils, characterized by clayey silt fractions, were reported by Arel and Önalp (2012) to have caused liquefaction-related settlements in the 1999 Adapazarı earthquake in Türkiye, akin to the liquefaction observed in İskenderun.

Figure 10. Granulometric analysis of the ten sand ejecta samples plotted on the Das (1983) diagram. The ejected materials primarily comprise fine-grained sand with 30 to 45 percent silt and clay. These size fractions clearly fall within the liquefiable range.

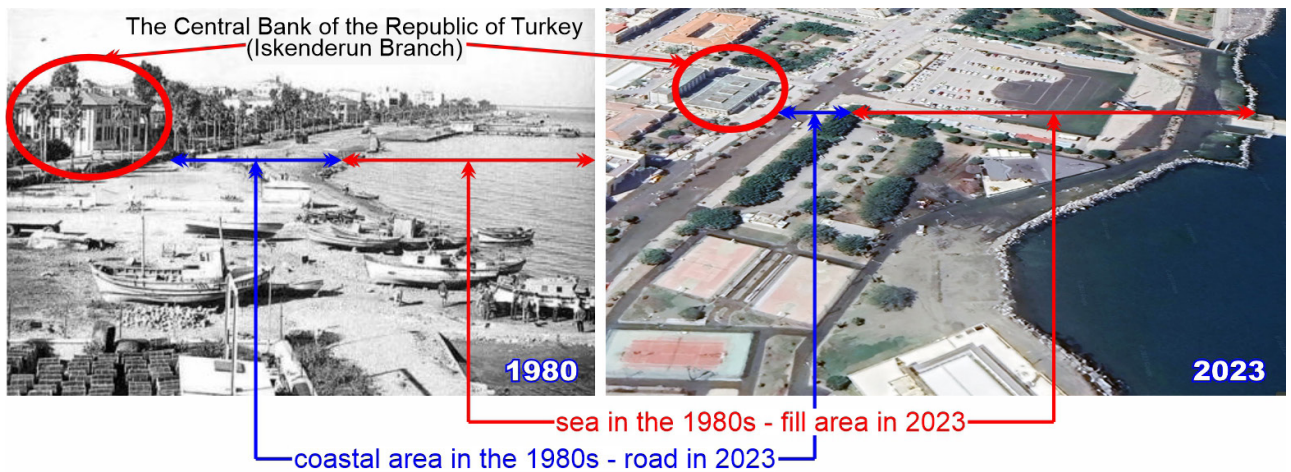
Figure 12. Changes in coastal, sea, and filling areas between 1980 and 2023.
