Earthquakes and Seismic Faulting: Effects on Tunnels

Abstract: A study of tunnels in areas affected by strong earthquakes in the last 50–100 years revealed at least three cases of tunnels damaged by earthquake shaking or offset by seismic faulting, including the Bolu (Turkey) twin tunnels, which collapsed during the 1999 Düzce earthquake. These data indicate that tunnels cannot be considered as structures invulnerable to earthquakes. Furthermore, the tectonic offset of tunnels shows that certain observed seismic surface ruptures are not necessarily indicative of tectonic faulting and represent only secondary local ground instability effects.

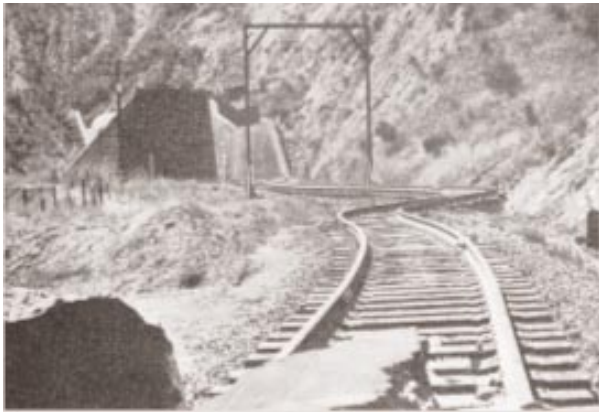
Figure 2. Kern County urban railway tunnel. A view from the entrance of the tunnel showing bent rails near a zone of intense fracturing along the White Wolf Fault. Source: SCECDC 2002.

A railway tunnel crossing the White Wolf Fault (WWF) was seriously damaged during the 1952 Kern County earthquake ($M_w=7.5$) associated with this fault (SCECDC 2002). After the earthquake both a compressive and a lateral component of displacement were detected on the ground surface along the WWF: rails, both inside and at the entrance of the tunnel, were bent (Figure 2), while locally the displaced rail was thrust by the 46-cm-thick tunnel lining (Figure 3).

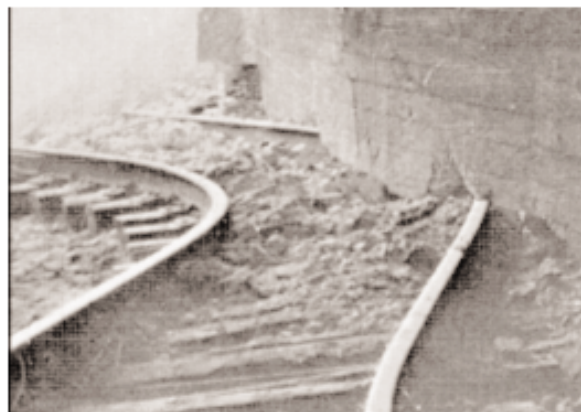
Figure 3. Bent rails inside the Kern County urban railway tunnel. The White Wolf Fault had a both compressive and lateral dislocation during the 1952 Kern County earthquake. Indicative of this type of fault dislocation is the fact that the rails are bent and continuous underneath the tunnel wall, showing that the wall was lifted up enough for the rail to slide underneath. Source: SCECDC 2002.
